Access Compliance Report

Public Rights-of-Way

(Curb Ramps)

Intersection ID: 32252	Main Street: BRYANT_FARMS_RD	Cross Street: BALMORAL_PARK_DR	Location:	E
ADA ID: 72021D286C40	Ramp Type: Perp	Initial Pass/Fail: Fail	Overall Compliance: No	Severity Score: 25

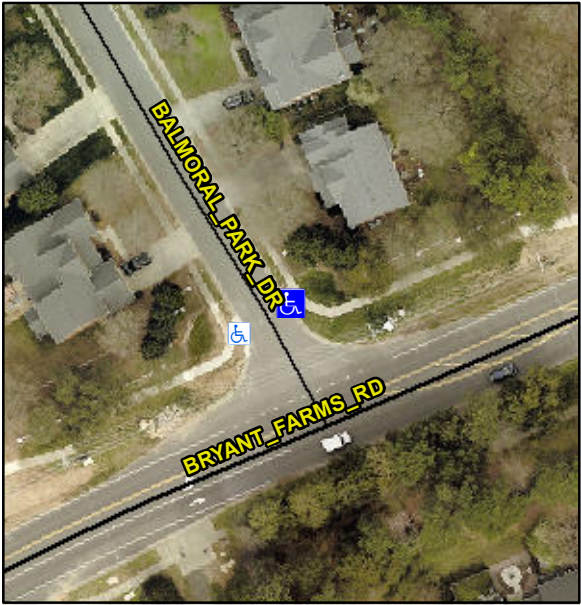
Possible Solutions:		Compliance	Description	Data
	Remove & Replace Entire Ramp.		No	Ramp Length (in)	96.0
			Yes	Ramp Width (in)	48.0
			N/A	Flare Type LT	N/A
			N/A	Flare Slope LT (%)	N/A
			N/A	Flare Traversable LT?	N/A
			N/A	Landing Length (in)	N/A
			N/A	Landing Width (in)	N/A
			N/A	Landing Slope (%)	N/A
			N/A	Landing X Slope (%)	N/A
<p>Surveyor Notes:</p> <p>N/A</p> <p>PROW/ADA:</p> <p>R304.2.2, R304.5.3</p>			N/A	Flare Type RT	N/A
			N/A	Flare Slope RT (%)	N/A
			N/A	Flare Traversable RT?	N/A
			N/A	DWS Provided?	N/A
			N/A	DWS Contrast?	N/A
			N/A	DWS Length (in)	N/A
			N/A	DWS Full Width?	N/A
			N/A	DWS Offset (in)	N/A
			N/A	Shared Landing?	N/A
			N/A	Gutter Ponding?	N/A
			N/A	Gutter Lip Ht (in)	N/A
			N/A	Painted X Walk1?	No
				X Walk 1 Direction	To W
			N/A	X Walk 1 Width (in)	N/A
				X Walk 1 Slope (%)	3.4
				X Walk 1 X Slope (%)	3.2

N/A	Ramp inside XWalk1?	N/A
			N/A	Road Slope (%)	N/A
			N/A	Road X Slope (%)	N/A
			N/A	Any Obstructions?	N/A
Total Cost:		\$ 1850.00		Obstruction Type	
			N/A	Storm Grate/Utility Hazard?	N/A
				Storm Grate/Utility Type	
			N/A		N/A
			Yes	Surface Condition? (G/P)	Good
