Access Compliance Report

Public Rights-of-Way

(Curb Ramps)

Intersection ID: 12957	Main Street: HAMORTON_PL	Cross Street: PECAN_AV	Location: SE
ADA ID: 7204A9B7B0C8	Ramp Type: PerpDiag	Initial Pass/Fail: Fail	Overall Compliance: No
		Severity Score: 12.5

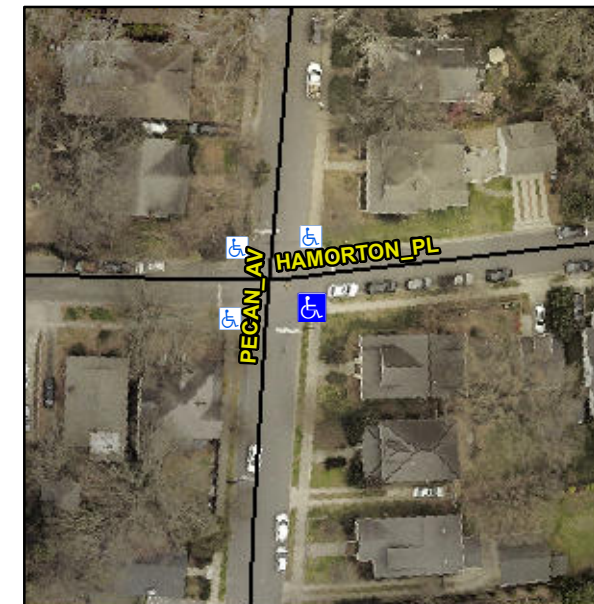
Not Found, R304.2.2

Compliance	Description	Data	Compliance	Description	Data
N/A	Ramp Length (in)	83.0	No	Ramp Slope (%)	8.4
Yes	Ramp Width (in)	63.0	Yes	Ramp XSlope (%)	1.5
N/A	Flare Type LT	N/A	N/A	Flare Type RT	N/A
N/A	Flare Slope LT (%)	N/A	N/A	Flare Slope RT (%)	N/A
N/A	Flare Traversable LT?	N/A	N/A	Flare Traversable RT?	N/A
N/A	Landing Length (in)	N/A	N/A	DWS Provided?	N/A
N/A	Landing Width (in)	N/A	N/A	DWS Contrast?	N/A
N/A	Landing Slope (%)	N/A	N/A	DWS Length (in)	N/A
N/A	Landing X Slope (%)	N/A	N/A	DWS Full Width?	N/A
N/A	Landing Curb? (Y/N)	N/A	N/A	DWS Offset (in)	N/A
N/A	Shared Landing?	N/A			
N/A	Gutter Ponding?	Yes	N/A	Gutter Slope (%)	N/A
N/A	Gutter Lip Ht (in)	N/A	N/A	Gutter X Slope (%)	N/A
N/A	Painted X Walk1?	No	N/A	Painted X Walk2?	No
	X Walk 1 Direction	To N		X Walk 2 Direction	To W
N/A	X Walk 1 Width (in)	N/A	N/A	X Walk 2 Width (in)	N/A
	X Walk 1 Slope (%)	0.9		X Walk 2 Slope (%)	1.2
	X Walk 1 X Slope (%)	3.5		X Walk 2 X Slope (%)	0.7

Remove & Replace Curb Ramp With Two New Directional Ramps or Equivalent.
