# Access Compliance Report

## Public Rights-of-Way

| Intersection ID: 43659 | Main Street: TAYLOR RIDGE LN | Cross Street: STARR NEELY RD | Location: NE |
| ADA ID: 7208966C47E7 | Ramp Type: PerpDiag | Initial Pass/Fail: Fail | Overall Compliance: No |

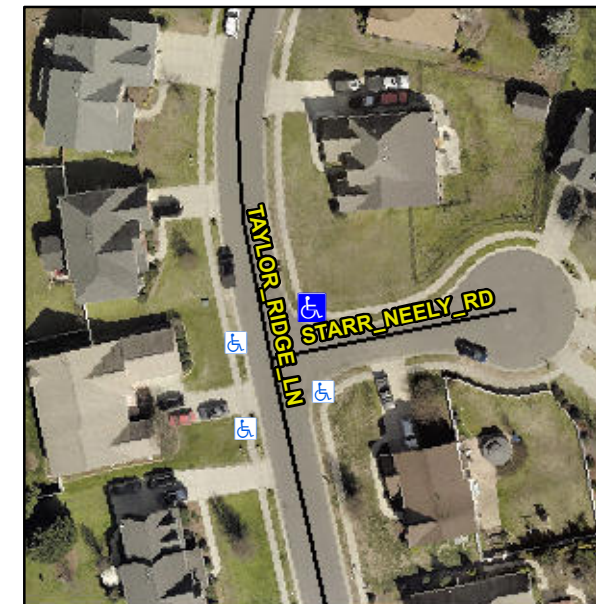
**Not Found, R304.5.1, R304.2.2, R304.5.3**

| Compliance | Description | Data | Compliance | Description | Data |
|---|---|---|---|---|---|
| N/A | Ramp Length (in) | 48.0 | No | Ramp Slope (%) | 8.9 |
| No | Ramp Width (in) | 38.0 | No | Ramp XSlope (%) | 4.4 |

**Remove & Replace Curb Ramp With Two New Directional Ramps or Equivalent.**
