## Access Compliance Report Public Rights-of-Way (Curb Ramps)

Intersection ID: N/A Main Street: OLD\_CONCORD\_RD Cross Street: ORCHID\_BRIDGE\_RD Location: NW

ADA ID: 720D0D48743C Ramp Type: Perp Initial Pass/Fail: Fail Overall Compliance: No Severity Score: 12.5

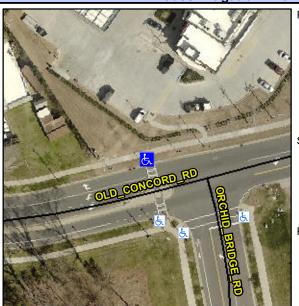
Field Measurements/Component Compliance						
Comp	liance Description	Data	Compl	liance Description	Data	
N/A	Ramp Length (in)	96.0	No	Ramp Slope (%)	8.7	
Yes	Ramp Width (in)	98.0	Yes	Ramp XSlope (%)	0.2	
N/A	Flare Type LT	N/A	N/A	Flare Type RT	N/A	
N/A	Flare Slope LT (%)	N/A	N/A	Flare Slope RT (%)	N/A	
N/A	Flare Traversable LT?	N/A	N/A	Flare Traversable RT?	N/A	
N/A	Landing Length (in)	N/A	N/A	DWS Provided?	N/A	
N/A	Landing Width (in)	N/A	N/A	DWS Contrast?	N/A	
N/A	Landing Slope (%)	N/A	N/A	DWS Length (in)	N/A	
N/A	Landing X Slope (%)	N/A	N/A	DWS Full Width?	N/A	
N/A	Landing Curb? (Y/N)	N/A	N/A	DWS Offset (in)	N/A	
N/A	Shared Landing?	N/A				
N/A	Gutter Ponding?	N/A	N/A	Gutter Slope (%)	N/A	
N/A	Gutter Lip Ht (in)	N/A	N/A	Gutter X Slope (%)	N/A	
N/A	Painted X Walk1?	Yes	N/A	Painted X Walk2?	N/A	
	X Walk 1 Direction	To S		X Walk 2 Direction	N/A	
N/A	X Walk 1 Width (in)	95.0	N/A	X Walk 2 Width (in)	N/A	
	X Walk 1 Slope (%)	2.4		X Walk 2 Slope (%)	N/A

X Walk 1 X Slope (%)	0.8		X Walk 2 X Slope (%)	N/A	
N/A	Ramp inside XWalk1?	Yes	N/A	Ramp inside XWalk2?	N/A	
	Road Slope (%)	N/A	N/A	Clear Space?	N/A	
	Road X Slope (%)	N/A	N/A	Clear Space to XWalk (in)	N/A	
N/A	Any Obstructions?	N/A	N/A	Storm Grate/Utility Hazard?	N/A	
	Obstruction Type			Storm Grate/Utility Type		
		N/A			N/A	
			Yes	Surface Condition? (G/P)	Good

1 Ossible Solution	
Possible Solutions:	Com
Remove & Replace Entire Ramp.	N/A
•	Yes
	N/A
	N/A
	N/A
	N/A
Surveyor Notes:	N/A
N/A	N/A
	N/A
	N/A
	N/A
PROW/ADA:	N/A
Not Found, R304.2.2	N/A
	N/A
	N/A
	N/A
