Access Compliance Report Public Rights-of-Way (Curb Ramps)

Intersection ID: 9246 Main Street: GRIMES_ST Cross Street: NORRIS_AV Location: SE **Overall Compliance: No** ADA ID: 722B0EB7E2B0 Ramp Type: PerpDiag Initial Pass/Fail: Fail **Severity Score:** 35

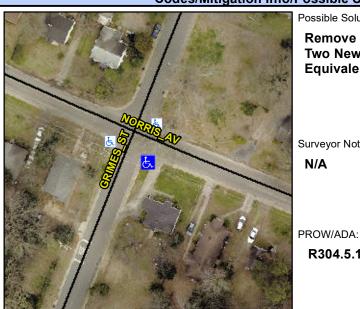
Compliance Description		Data	Compliance Description		Data
N/A	Ramp Length (in)	52.0	No	Ramp Slope (%)	13.4
No	Ramp Width (in)	47.0	No	Ramp XSlope (%)	4.8
N/A	Flare Type LT	N/A	N/A	Flare Type RT	N/A
N/A	Flare Slope LT (%)	N/A	N/A	Flare Slope RT (%)	N/A
N/A	Flare Traversable LT?	N/A	N/A	Flare Traversable RT?	N/A
N/A	Landing Length (in)	N/A	N/A	DWS Provided?	N/A
N/A	Landing Width (in)	N/A	N/A	DWS Contrast?	N/A
N/A	Landing Slope (%)	N/A	N/A	DWS Length (in)	N/A
N/A	Landing X Slope (%)	N/A	N/A	DWS Full Width?	N/A
N/A	Landing Curb? (Y/N)	N/A	N/A	DWS Offset (in)	N/A
N/A	Shared Landing?	N/A			
N/A	Gutter Ponding?	N/A	N/A	Gutter Slope (%)	N/A
N/A	Gutter Lip Ht (in)	N/A	N/A	Gutter X Slope (%)	N/A
N/A	Painted X Walk1?	No	N/A	Painted X Walk2?	No
	X Walk 1 Direction	To NE		X Walk 2 Direction	To NW
N/A	X Walk 1 Width (in)	N/A	N/A	X Walk 2 Width (in)	N/A
	X Walk 1 Slope (%)	6.2		X Walk 2 Slope (%)	0.4
	X Walk 1 X Slope (%)	0.6		X Walk 2 X Slope (%)	5.2

N/A	Ramp inside XWalk1?	N/A	N/A	Ramp inside XWalk2?	N/A
	Road Slope (%)	3.2	N/A	Clear Space?	N/A
	Road X Slope (%)	8.1	N/A	Clear Space to XWalk (in)	N/A
N/A	Any Obstructions?	N/A	N/A	Storm Grate/Utility Hazard?	N/A
	Obstruction Type			Storm Grate/Utility Type

Possible Solutions: Remove & Replace Curb Ramp With Two New Directional Ramps or Equivalent. Surveyor Notes:

R304.5.1, R304.2.2, R304.5.3
