Access Compliance Report

Public Rights-of-Way

(Curb Ramps)

Intersection ID: 13595	Main Street: DEWBERRY_TR	Cross Street: DR_CARVER_RD	Location: SE
ADA ID: 722FAD7FAD27	Ramp Type: Perp	Initial Pass/Fail: Fail	Overall Compliance: No
Severity Score: 21.25			
Codes/Mitigation Info/Possible Solution		Field Measurements/Component Compliance

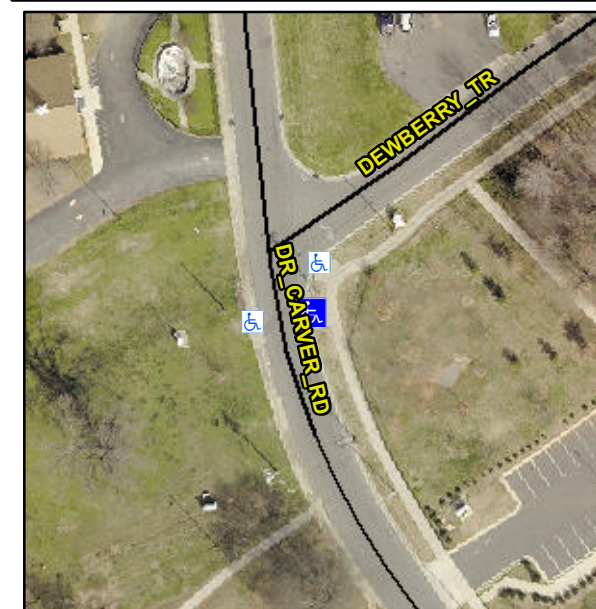
Not Found, R304.5.1, R304.5.3

Compliance	Description	Data	Compliance	Description	Data
N/A	Ramp Length (in)	96.0	Yes	Ramp Slope (%)	6.5
No	Ramp Width (in)	47.0	No	Ramp XSlope (%)	5.1
N/A	Flare Type LT	N/A	N/A	Flare Type RT	N/A
N/A	Flare Slope LT (%)	N/A	N/A	Flare Slope RT (%)	N/A
N/A	Flare Traversable LT?	N/A	N/A	Flare Traversable RT?	N/A
N/A	Landing Length (in)	N/A	N/A	DWS Provided?	N/A
N/A	Landing Width (in)	N/A	N/A	DWS Contrast?	N/A
N/A	Landing Slope (%)	N/A	N/A	DWS Length (in)	N/A
N/A	Landing X Slope (%)	N/A	N/A	DWS Full Width?	N/A
N/A	Landing Curb? (Y/N)	N/A	N/A	DWS Offset (in)	N/A
N/A	Shared Landing?	N/A			
N/A	Gutter Ponding?	N/A	N/A	Gutter Slope (%)	N/A
N/A	Gutter Lip Ht (in)	N/A	N/A	Gutter X Slope (%)	N/A
N/A	Painted X Walk1?	No	N/A	Painted X Walk2?	N/A
	X Walk 1 Direction	To W		X Walk 2 Direction	N/A
N/A	X Walk 1 Width (in)	N/A	N/A	X Walk 2 Width (in)	N/A
	X Walk 1 Slope (%)	5.6		X Walk 2 Slope (%)	N/A
	X Walk 1 X Slope (%)	3.9		X Walk 2 X Slope (%)	N/A

N/A	Ramp inside XWalk1?	N/A	N/A	Ramp inside XWalk2?	N/A
	Road Slope (%)	N/A	N/A	Clear Space?	N/A
	Road X Slope (%)	N/A	N/A	Clear Space to XWalk (in)	N/A
N/A	Any Obstructions?	N/A	N/A	Storm Grate/Utility Hazard?	N/A
	Obstruction Type			Storm Grate/Utility Type	
		N/A			N/A
			Yes	Surface Condition? (G/P)	Good

Possible Solutions:

Remove & Replace Entire Ramp.
