Access Compliance Report

Public Rights-of-Way

(Curb Ramps)

Intersection ID: 10020356	Main Street: BALLANTYNE_COMMONS_PY	Cross Street: N/A	Location: W
ADA ID: 726238825595	Ramp Type: Directional1	Initial Pass/Fail: Fail	Overall Compliance: No
Severity Score: 1.25			
Codes/Mitigation Info/Possible Solution		Field Measurements/Component Compliance

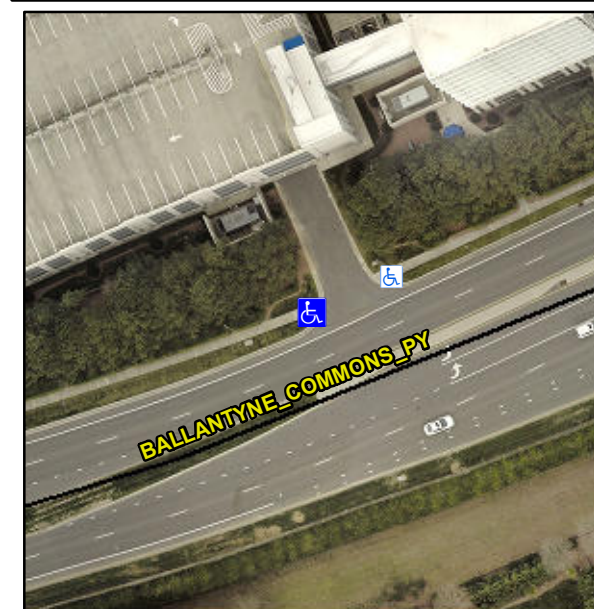
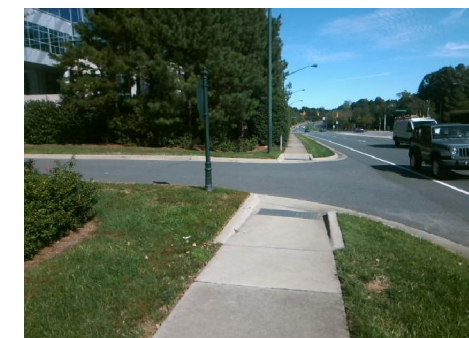
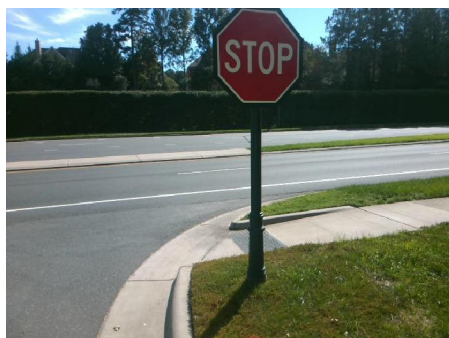
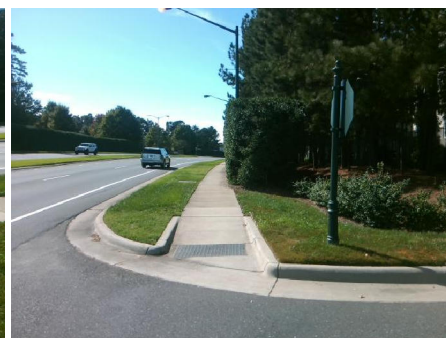
Compliance	Description	Data	Compliance	Description	Data
N/A	Ramp Length (in)	102.0	N/A	Grade Break?	N/A
Yes	Ramp Width (in)	58.0	N/A	Grade Break Slope (%)	0.0
Yes	Ramp Slope (%)	7.9	N/A	Grade Break XSlope (%)	0.0
No	Ramp XSlope (%)	3.7			
N/A	Flare Type LT	N/A	N/A	Flare Type RT	N/A
N/A	Flare Slope LT (%)	N/A	N/A	Flare Slope RT (%)	0.0
N/A	Flare Traversable LT?	N/A	N/A	Flare Traversable RT?	N/A
N/A	Landing Length (in)	0.0	N/A	DWS Provided?	N/A
N/A	Landing Width (in)	0.0	N/A	DWS Contrast?	N/A
N/A	Landing Slope (%)	0.0	N/A	DWS Length (in)	N/A
N/A	Landing X Slope (%)	0.0	N/A	DWS Full Width?	N/A
N/A	Landing Curb? (Y/N)	N/A	N/A	DWS Offset LT (in)	N/A
N/A	Shared Landing?	N/A	N/A	DWS Offset RT (in)	N/A
N/A	Gutter Ponding?	0.0	N/A	Gutter Slope (%)	N/A
N/A	Gutter Lip Ht (in)	0.0	N/A	Gutter X Slope (%)	N/A
N/A	Painted X Walk1?	No		Road Slope (%)	1.9
	X Walk 1 Direction	To NE		Road X Slope (%)	3.8
	X Walk 1 Width (in)	N/A		Clear Space?	N/A

X Walk 1 Slope (%)	1.9	N/A	Clear Space to XWalk (in)	N/A
	X Walk 1 X Slope (%)	3.8	N/A	Storm Grate/Utility Hazard?	N/A
N/A	Ramp inside XWalk1?	N/A		Storm Grate/Utility Type	
N/A	Any Obstructions?	N/A			N/A
	Obstruction Type		Yes	Surface Condition? (G/P)	Good
			N/A	Curb Slope (%)	3.4

Remove & Replace Entire Ramp.
