Access Compliance Report

Public Rights-of-Way

(Curb Ramps)

| Intersection ID: 13635 | Main Street: E_BLAND_ST | Cross Street: SOUTH_BV | Location: NW |

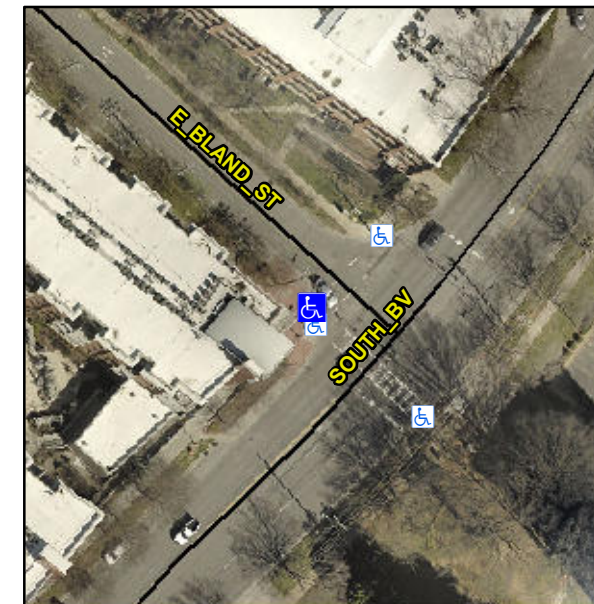
| ADA ID: 72711D3B000E | Ramp Type: Perp | Initial Pass/Fail: Fail | Overall Compliance: No |

R304.5.1, R304.2.2, R304.5.3

| Compliance | Description | Data | Compliance | Description | Data |
|---|---|---|---|---|---|
| N/A | Ramp Length (in) | 90.0 | No | Ramp Slope (%) | 10.3 |
| No | Ramp Width (in) | 46.0 | No | Ramp XSlope (%) | 5.1 |

Remove & Replace Entire Ramp.
