Access Compliance Report Public Rights-of-Way (Curb Ramps)

Intersection ID: 10023820	section ID: 10023820 Main Street: COLONY PD				Cross Street: N/A					SE
									Location:	
ADA ID: 7280B0C94D40	30C94D40 Ramp Type: Perp			Initial Pass/Fail: Fail Overall Compliance: No					o Severity Score:	21.25
Codes/Mitigation Info/Possible Solution				Field Measurements/Component Compliance						
		Possible Solutions:		Compliance Description E			Data	ata Compliance Description		Data
	THE AND	Remove & Repl	ace Entire Ramp.		N/A	Ramp Length (in)	56.0	Yes	Ramp Slope (%)	5.2
	A Contractor				No	Ramp Width (in)	40.0	No	Ramp XSlope (%)	6.7

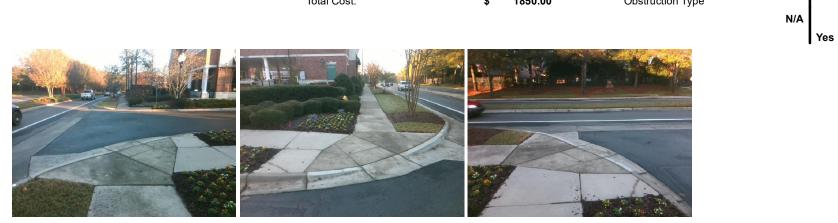
6.	and the state of the state of				N/A	Flare Type LT	N/A	N/A	Flare Type RT	N/A
WISLEY	and the second				N/A	Flare Slope LT (%)	N/A	N/A	Flare Slope RT (%)	N/A
	and the second				N/A	Flare Traversable LT?	N/A	N/A	Flare Traversable RT?	N/A
the last	and the second s				N/A	Landing Length (in)	N/A	N/A	DWS Provided?	N/A
	THE WE BAL	Surveyor Notes:			N/A	Landing Width (in)	N/A	N/A	DWS Contrast?	N/A
	JU - 2-	N/A			N/A	Landing Slope (%)	N/A	N/A	DWS Length (in)	N/A
EN LA LA VAL	in the second	2			N/A	Landing X Slope (%)	N/A	N/A	DWS Full Width?	N/A
	total and				N/A	Landing Curb? (Y/N)	N/A	N/A	DWS Offset (in)	N/A

- TI				N/A	Shared Landing?	N/A			
	1 - 1	PROW/ADA:			N/A	Gutter Ponding?	N/A	N/A	Gutter Slope (%)	N/A
	DIST	Not Found, R30	4.5.1. R304.5.3		N/A	Gutter Lip Ht (in)	N/A	N/A	Gutter X Slope (%)	N/A
		,,	,		N/A	Painted X Walk1?	No	N/A	Painted X Walk2?	N/A
		1				X Walk 1 Direction	To N		X Walk 2 Direction	N/A
					N/A	X Walk 1 Width (in)	N/A	N/A	X Walk 2 Width (in)	N/A
Street 1 Name	ENTRANCE	_				X Walk 1 Slope (%)	0.1		X Walk 2 Slope (%)	N/A
Stop Condition-Street 2	StopSign					X Walk 1 X Slope (%)	4.8		X Walk 2 X Slope (%)	N/A
Street 2 Name	N/A				N/A	Ramp inside XWalk1?	N/A	N/A	Ramp inside XWalk2?	N/A
Stop Condition-Street 1	N/A					Road Slope (%)	N/A	N/A	Clear Space?	N/A
						Road X Slope (%)	N/A	N/A	Clear Space to XWalk (in)	N/A
					N/A	Any Obstructions?	N/A	N/A	Storm Grate/Utility Hazard?	N/A
		Total Cost:	\$ 1	850.00		Obstruction Type			Storm Grate/Utility Type	
						••	N/A			N/A
