Access Compliance Report

Public Rights-of-Way

(Curb Ramps)

Intersection ID: N/A	Main Street: LANCASTER HWY	Cross Street: TRAFFORD PL	Location: E
ADA ID: 7280F0673580	Ramp Type: PerpDiag	Initial Pass/Fail: Pass	Overall Compliance: No
Codes/Mitigation Info/Possible Solution		Field Measurements/Component Compliance	
Severity Score: 7.5

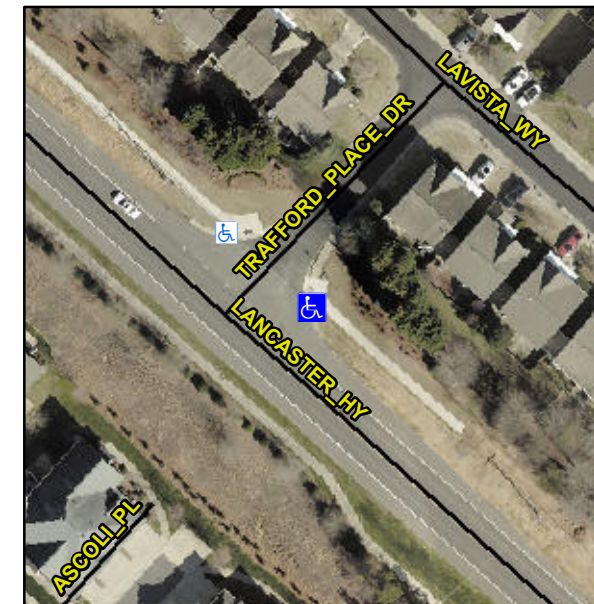
Compliance	Description	Data	Compliance	Description	Data
N/A	Ramp Length (in)	73.0	Yes	Ramp Slope (%)	8.1
Yes	Ramp Width (in)	60.0	Yes	Ramp XSlope (%)	1.0
N/A	Flare Type LT	Sloped	N/A	Flare Type RT	N/A
N/A	Flare Slope LT (%)	4.8	Yes	Flare Slope RT (%)	6.4
N/A	Flare Traversable LT?	Yes	N/A	Flare Traversable RT?	Yes
No	Landing Length (in)	39.5	Yes	DWS Provided?	Yes
Yes	Landing Width (in)	60.0	Yes	DWS Contrast?	Yes
Yes	Landing Slope (%)	0.7	Yes	DWS Length (in)	24.0
Yes	Landing X Slope (%)	0.0	Yes	DWS Full Width?	Yes
N/A	Landing Curb? (Y/N)	No	Yes	DWS Offset (in)	2.0
N/A	Shared Landing?	No			
Yes	Gutter Ponding?	No	Yes	Gutter Slope (%)	1.7
No	Gutter Lip Ht (in)	0.5	Yes	Gutter X Slope (%)	2.0
N/A	Painted X Walk1?	No	N/A	Painted X Walk2?	No
	X Walk 1 Direction	To NW		X Walk 2 Direction	To SW
N/A	X Walk 1 Width (in)	N/A	N/A	X Walk 2 Width (in)	N/A
	X Walk 1 Slope (%)	1.7		X Walk 2 Slope (%)	1.2
	X Walk 1 X Slope (%)	0.9		X Walk 2 X Slope (%)	1.7

N/A	Ramp inside XWalk1?	N/A	N/A	Ramp inside XWalk2?	N/A
	Road Slope (%)	1.1	N/A	Clear Space?	Yes
	Road X Slope (%)	0.5	N/A	Clear Space to XWalk (in)	N/A
Yes	Any Obstructions?	No	Yes	Storm Grate/Utility Hazard?	No
	Obstruction Type			Storm Grate/Utility Type	
		N/A			N/A
			Yes	Surface Condition? (G/P)	Good

Remove & Replace Landing. Grind Gutter Lip.

R304.2.1, R302.7.2
