Access Compliance Report Public Rights-of-Way (Curb Ramps)

Intersection ID: N/AMain Street:MUNSEE_STCross Street:W_SUGAR_CREEK_RDLocation:NEADA ID: 728442EE5805Ramp Type:Combination2DiagInitial Pass/Fail:FailOverall Compliance:NoSeverity Score:0

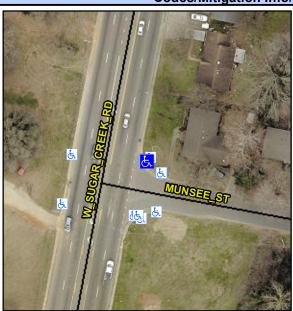
Not Found, R304.5.1, R304.5.3

Remove & Replace Curb Ramp With Two New Directional Ramps or Equivalent. Remove & Replace Sidewalk.
