# Access Compliance Report

## Public Rights-of-Way

### (Curb Ramps)

Intersection ID: 15818	Main Street: CHEROKEE_PL	Cross Street: HEMPSTEAD_PL	Location: SW
ADA ID: 729ADDD83950	Ramp Type: PerpDiag	Initial Pass/Fail: Fail	Overall Compliance: No
			Severity Score: 26.25

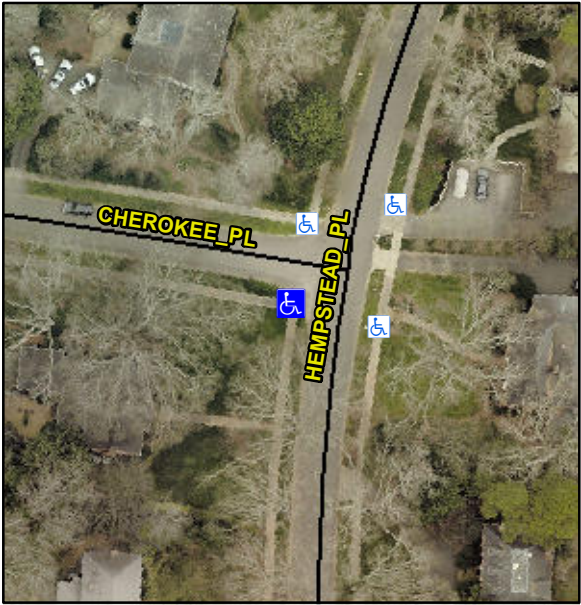
Possible Solutions:		<b>Compliance</b>	<b>Description</b>	<b>Data</b>
	<b>Remove &amp; Replace Curb Ramp With Two New Directional Ramps or Equivalent.</b>		<b>No</b>	Ramp Length (in)	<b>35.0</b>
			<b>Yes</b>	Ramp Width (in)	<b>48.0</b>
			<b>N/A</b>	Flare Type LT	<b>N/A</b>
			<b>N/A</b>	Flare Slope LT (%)	<b>N/A</b>
			<b>N/A</b>	Flare Traversable LT?	<b>N/A</b>
			<b>N/A</b>	Landing Length (in)	<b>N/A</b>
			<b>N/A</b>	Landing Width (in)	<b>N/A</b>
			<b>N/A</b>	Landing Slope (%)	<b>N/A</b>
			<b>N/A</b>	Landing X Slope (%)	<b>N/A</b>
<p>Surveyor Notes:</p> <p><b>N/A</b></p> <p>PROW/ADA:</p> <p><b>Not Found, R304.2.2, R304.5.3</b></p>			<b>N/A</b>	Flare Type RT	<b>N/A</b>
			<b>N/A</b>	Flare Slope RT (%)	<b>N/A</b>
			<b>N/A</b>	Flare Traversable RT?	<b>N/A</b>
			<b>N/A</b>	DWS Provided?	<b>N/A</b>
			<b>N/A</b>	DWS Contrast?	<b>N/A</b>

<b>N/A</b>	DWS Length (in)	<b>N/A</b>
			<b>N/A</b>	DWS Full Width?	<b>N/A</b>
			<b>N/A</b>	DWS Offset (in)	<b>N/A</b>
			<b>N/A</b>	Gutter Ponding?	<b>N/A</b>
			<b>N/A</b>	Gutter Lip Ht (in)	<b>N/A</b>
<p>Total Cost:</p> <p><b>\$ 3200.00</b></p>			<b>No</b>	Painted X Walk2?	<b>No</b>
			<b>To E</b>	X Walk 2 Direction	<b>To N</b>
			<b>N/A</b>	X Walk 2 Width (in)	<b>N/A</b>
			<b>2.3</b>	X Walk 2 Slope (%)	<b>3.0</b>
			<b>4.1</b>	X Walk 2 X Slope (%)	<b>1.4</b>
			<b>N/A</b>	Ramp inside XWalk2?	<b>N/A</b>
			<b>2.3</b>	Clear Space?	<b>N/A</b>
			<b>1.8</b>	Clear Space to XWalk (in)	<b>N/A</b>
			<b>N/A</b>	Storm Grate/Utility Hazard?	<b>N/A</b>
			<b>N/A</b>	Storm Grate/Utility Type	<b>N/A</b>
			<b>N/A</b>	Surface Condition? (G/P)	<b>Good</b>
