Access Compliance Report

Public Rights-of-Way

(Curb Ramps)

Intersection ID: 3908	Main Street: BULLE ROCK CT	Cross Street: WOODCOCK LN	Location: SE
ADA ID: 72A6F154CE90	Ramp Type: Perp	Initial Pass/Fail: Fail	Overall Compliance: No
Codes/Mitigation Info/Possible Solution		Field Measurements/Component Compliance	
Severity Score: 33.75

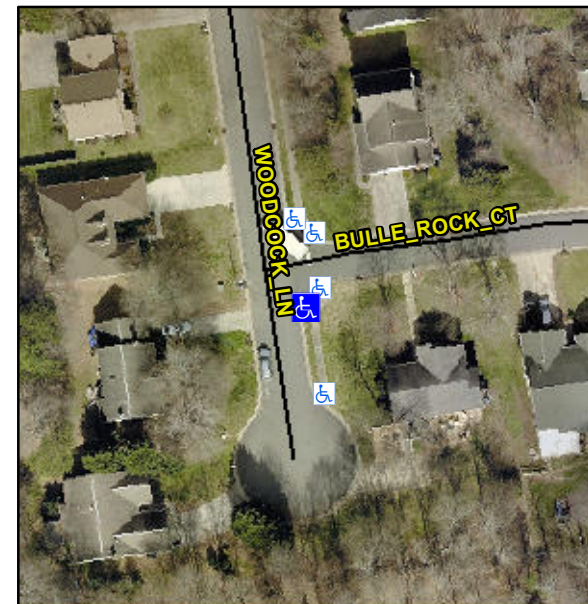
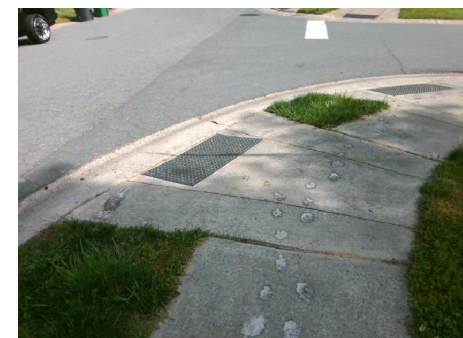
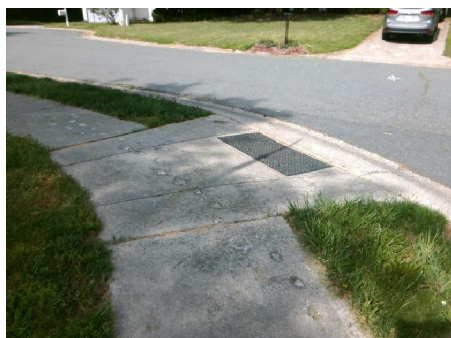
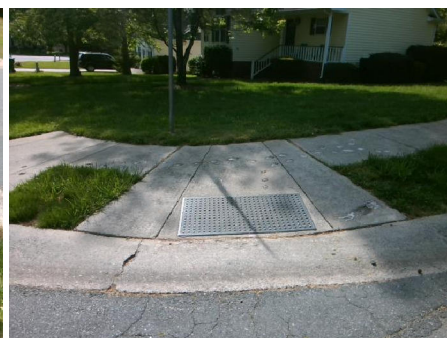
Not Found, R304.5.1, R304.2.2, R304.5.3

Compliance	Description	Data	Compliance	Description	Data
N/A	Ramp Length (in)	45.0	No	Ramp Slope (%)	9.2
No	Ramp Width (in)	44.0	No	Ramp XSlope (%)	6.0
N/A	Flare Type LT	N/A	N/A	Flare Type RT	N/A
N/A	Flare Slope LT (%)	N/A	N/A	Flare Slope RT (%)	N/A
N/A	Flare Traversable LT?	N/A	N/A	Flare Traversable RT?	N/A
N/A	Landing Length (in)	N/A	N/A	DWS Provided?	N/A
N/A	Landing Width (in)	N/A	N/A	DWS Contrast?	N/A
N/A	Landing Slope (%)	N/A	N/A	DWS Length (in)	N/A
N/A	Landing X Slope (%)	N/A	N/A	DWS Full Width?	N/A
N/A	Landing Curb? (Y/N)	N/A	N/A	DWS Offset (in)	N/A
N/A	Shared Landing?	N/A			
N/A	Gutter Ponding?	N/A	N/A	Gutter Slope (%)	N/A
N/A	Gutter Lip Ht (in)	N/A	N/A	Gutter X Slope (%)	N/A
N/A	Painted X Walk1?	No	N/A	Painted X Walk2?	N/A
	X Walk 1 Direction	To W		X Walk 2 Direction	N/A
N/A	X Walk 1 Width (in)	N/A	N/A	X Walk 2 Width (in)	N/A
	X Walk 1 Slope (%)	2.3		X Walk 2 Slope (%)	N/A
	X Walk 1 X Slope (%)	1.9		X Walk 2 X Slope (%)	N/A

N/A	Ramp inside XWalk1?	N/A	N/A	Ramp inside XWalk2?	N/A
	Road Slope (%)	1.9	N/A	Clear Space?	N/A
	Road X Slope (%)	2.3	N/A	Clear Space to XWalk (in)	N/A
N/A	Any Obstructions?	N/A	N/A	Storm Grate/Utility Hazard?	N/A
	Obstruction Type			Storm Grate/Utility Type	
		N/A			N/A
			Yes	Surface Condition? (G/P)	Good

Possible Solutions:

Remove & Replace Entire Ramp.
