# Access Compliance Report

## Public Rights-of-Way

### (Curb Ramps)

Intersection ID: 26037	Main Street: FLOWERING_DOGWOOD_LN	Cross Street: STAPLETON_LN	Location: SW
ADA ID: 72A97BA54134	Ramp Type: Perp	Initial Pass/Fail: Fail	Overall Compliance: No
Severity Score: 21.25			
Codes/Mitigation Info/Possible Solution		Field Measurements/Component Compliance

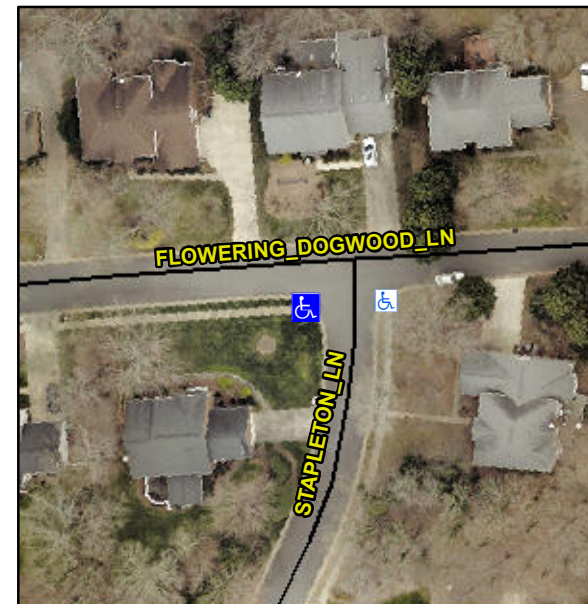
**Not Found, R304.5.1, R304.2.2**

Compliance	Description	Data	Compliance	Description	Data
N/A	Ramp Length (in)	59.0	No	Ramp Slope (%)	10.1
No	Ramp Width (in)	41.0	Yes	Ramp XSlope (%)	1.2
N/A	Flare Type LT	N/A	N/A	Flare Type RT	N/A
N/A	Flare Slope LT (%)	N/A	N/A	Flare Slope RT (%)	N/A
N/A	Flare Traversable LT?	N/A	N/A	Flare Traversable RT?	N/A
N/A	Landing Length (in)	N/A	N/A	DWS Provided?	N/A
N/A	Landing Width (in)	N/A	N/A	DWS Contrast?	N/A
N/A	Landing Slope (%)	N/A	N/A	DWS Length (in)	N/A
N/A	Landing X Slope (%)	N/A	N/A	DWS Full Width?	N/A
N/A	Landing Curb? (Y/N)	N/A	N/A	DWS Offset (in)	N/A
N/A	Shared Landing?	N/A			
N/A	Gutter Ponding?	N/A	N/A	Gutter Slope (%)	N/A
N/A	Gutter Lip Ht (in)	N/A	N/A	Gutter X Slope (%)	N/A
N/A	Painted X Walk1?	No	N/A	Painted X Walk2?	N/A
	X Walk 1 Direction	To E		X Walk 2 Direction	N/A
N/A	X Walk 1 Width (in)	N/A	N/A	X Walk 2 Width (in)	N/A
	X Walk 1 Slope (%)	1.9		X Walk 2 Slope (%)	N/A
	X Walk 1 X Slope (%)	4.6		X Walk 2 X Slope (%)	N/A

**Remove & Replace Entire Ramp.**

Total Cost: \$ 1850.00

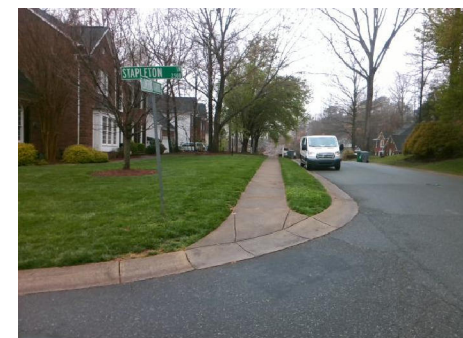
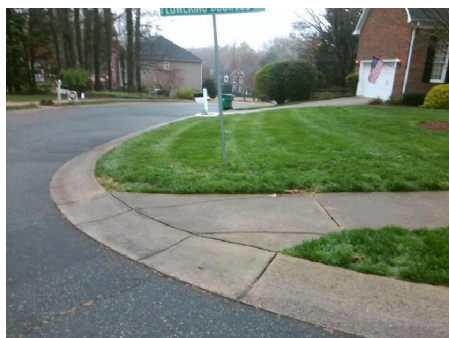
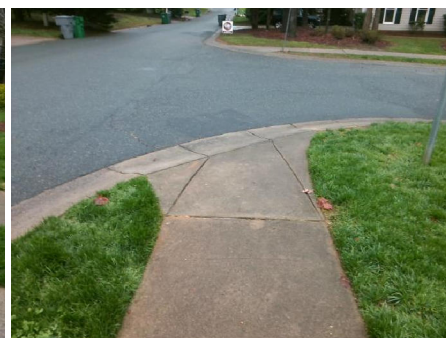
N/A	Ramp inside XWalk1?	N/A	N/A	Ramp inside XWalk2?	N/A
	Road Slope (%)	N/A	N/A	Clear Space?	N/A
	Road X Slope (%)	N/A	N/A	Clear Space to XWalk (in)	N/A
N/A	Any Obstructions?	N/A	N/A	Storm Grate/Utility Hazard?	N/A
	Obstruction Type			Storm Grate/Utility Type	
		N/A			N/A
			Yes	Surface Condition? (G/P)	Good
