Access Compliance Report

Public Rights-of-Way

(Curb Ramps)

| Intersection ID: 14147 | Main Street: CHERRY_ST | Cross Street: LUTHER_ST | Location: NW |

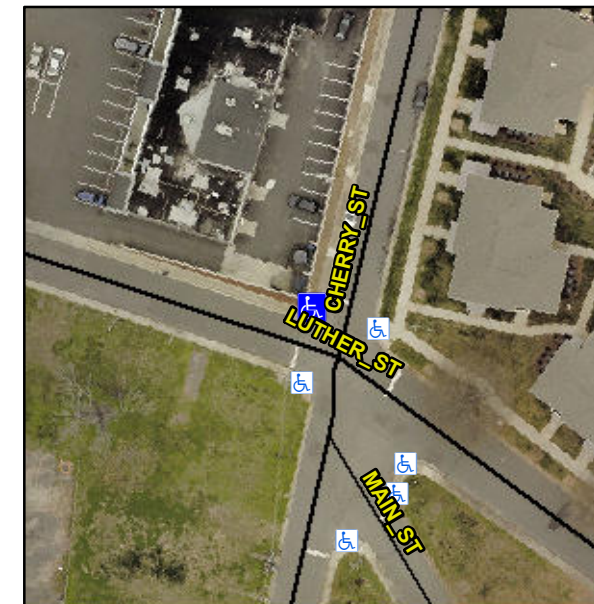
| ADA ID: 72BC74DC6D84 | Ramp Type: PerpDiag | Initial Pass/Fail: Fail | Overall Compliance: No |
| | | Severity Score: 37.5 | |

Not Found, R304.2.2, R304.5.3

| Compliance | Description | Data | Compliance | Description | Data |
|---|---|---|---|---|---|
| N/A | Ramp Length (in) | 47.0 | No | Ramp Slope (%) | 11.3 |
| Yes | Ramp Width (in) | 48.0 | No | Ramp XSlope (%) | 7.8 |

Remove & Replace Curb Ramp With Two New Directional Ramps or Equivalent.

Total Cost: \$ 3200.00
