Access Compliance Report

Public Rights-of-Way

(Curb Ramps)

Intersection ID: 31813	Main Street: WENDOVER_HILL_CT	Cross Street: CHURCHILL_RD	Location: NW
ADA ID: 72D3F779B386	Ramp Type: BlendTrans1	Initial Pass/Fail: Fail	Overall Compliance: No
Severity Score: 33.75			
Codes/Mitigation Info/Possible Solution		Field Measurements/Component Compliance

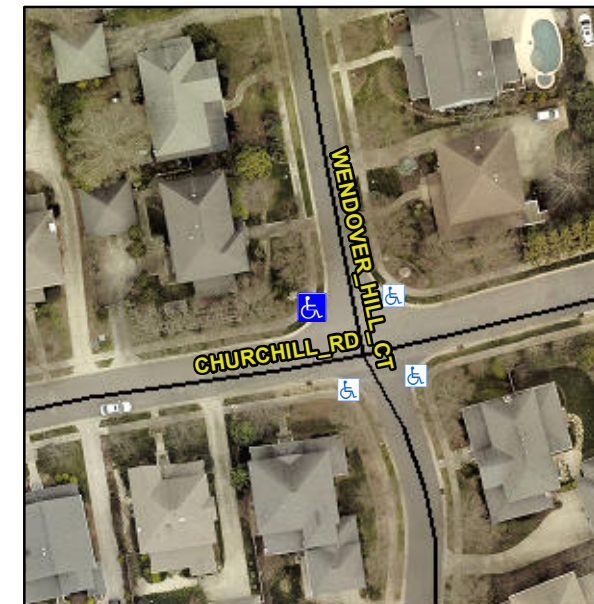
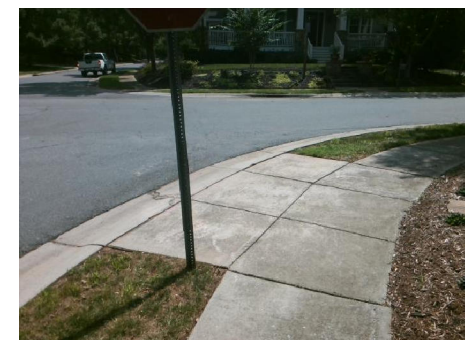
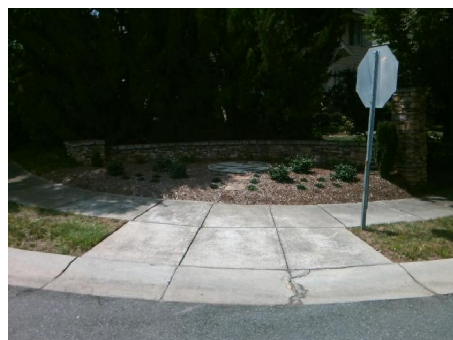
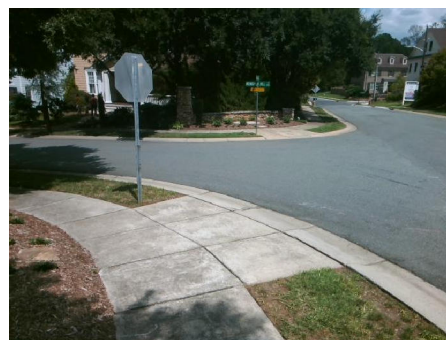
Not Found, R304.5.1, R304.5.3

Compliance	Description	Data	Compliance	Description	Data
N/A	Ramp Length (in)	48.0	Yes	BlendTrans Slope (%)	3.7
No	Ramp Width (in)	44.0	No	BlendTrans XSlope (%)	7.2
N/A	Flare Type LT	N/A	N/A	Flare Type RT	N/A
N/A	Flare Slope LT (%)	N/A	N/A	Flare Slope RT (%)	N/A
N/A	Flare Traversable LT?	N/A	N/A	Flare Traversable RT?	N/A
N/A	Landing Length (in)	N/A	N/A	DWS Provided?	N/A
N/A	Landing Width (in)	N/A	N/A	DWS Contrast?	N/A
N/A	Landing Slope (%)	N/A	N/A	DWS Length (in)	N/A
N/A	Landing X Slope (%)	N/A	N/A	DWS Full Width?	N/A
N/A	Landing Curb? (Y/N)	N/A	N/A	DWS Offset (in)	N/A
N/A	Shared Landing?	N/A			
N/A	Gutter Ponding?	N/A	N/A	Gutter Slope (%)	N/A
N/A	Gutter Lip Ht (in)	N/A	N/A	Gutter X Slope (%)	N/A
N/A	Painted X Walk1?	No	N/A	Painted X Walk2?	No
	X Walk 1 Direction	To S		X Walk 2 Direction	To E
	X Walk 1 Width (in)	N/A		X Walk 2 Width (in)	N/A
	X Walk 1 Slope (%)	2.9		X Walk 2 Slope (%)	1.5
	X Walk 1 X Slope (%)	2.2		X Walk 2 X Slope (%)	4.3

N/A	Ramp inside XWalk1?	N/A	N/A	Ramp inside XWalk2?	N/A
	Road Slope (%)	5.5		Clear Space?	N/A
	Road X Slope (%)	4.4	N/A	Clear Space to XWalk (in)	N/A
N/A	Any Obstructions?	N/A	N/A	Storm Grate/Utility Hazard?	N/A
	Obstruction Type			Storm Grate/Utility Type	
		N/A			N/A
		Yes		Surface Condition? (G/P)	Good
		No		Curb Slope (%)	15.4

Remove & Replace Curb Ramp With Two New Directional Ramps or Equivalent.
