# Access Compliance Report

## Public Rights-of-Way

### (Curb Ramps)

| Intersection ID: 16683 | Main Street: RENSFORD_AV | Cross Street: SHARON_RD | Location: NE |

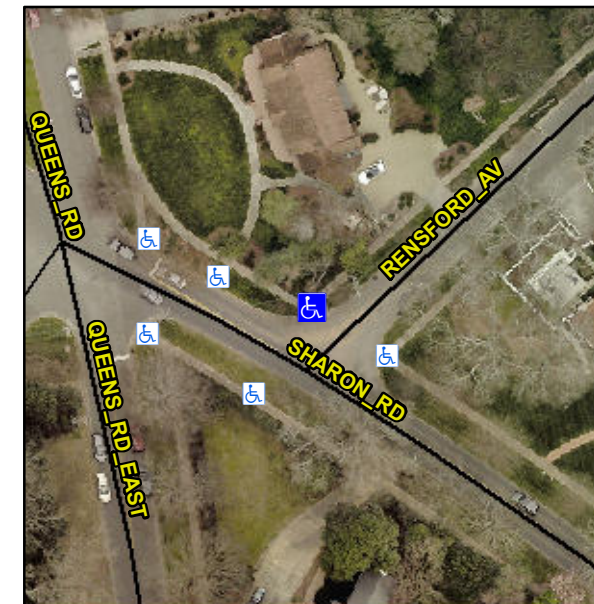
| ADA ID: 72D5DD6ECAA1 | Ramp Type: PerpDiag | Initial Pass/Fail: Fail | Overall Compliance: No |
| Severity Score: 21.25 | | | |

**Not Found, R304.5.1, R304.2.2**

| Compliance | Description | Data | Compliance | Description | Data |
|---|---|---|---|---|---|
| N/A | Ramp Length (in) | 64.0 | No | Ramp Slope (%) | 9.1 |
| No | Ramp Width (in) | 41.0 | Yes | Ramp XSlope (%) | 0.3 |

**Remove & Replace Curb Ramp With Two New Directional Ramps or Equivalent.**

Total Cost: \$ 3200.00
