# Access Compliance Report

## Public Rights-of-Way (Curb Ramps)

Intersection ID: 15242	Main Street: E_INDEPENDENCE_BV	Cross Street: N_WENDOVER_RD_RA	Location: SE
ADA ID: 72DE9DA2CA34	Ramp Type: Perp	Initial Pass/Fail: Fail	Overall Compliance: No
		Severity Score: 37.5

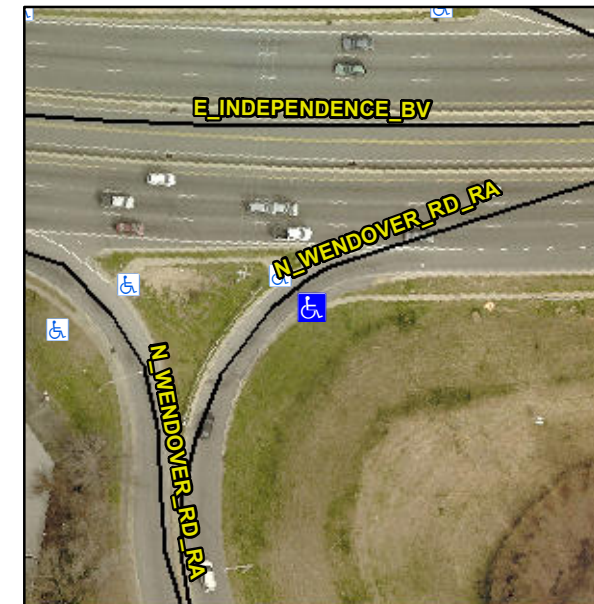
**Not Found, R304.5.1, R304.2.2,  
R304.5.3, R302.7**

Compliance	Description	Data	Compliance	Description	Data
N/A	Ramp Length (in)	80.5	No	Ramp Slope (%)	8.6
No	Ramp Width (in)	43.0	No	Ramp XSlope (%)	2.4
N/A	Flare Type LT	N/A	N/A	Flare Type RT	N/A
N/A	Flare Slope LT (%)	N/A	N/A	Flare Slope RT (%)	N/A
N/A	Flare Traversable LT?	N/A	N/A	Flare Traversable RT?	N/A
N/A	Landing Length (in)	N/A	N/A	DWS Provided?	N/A
N/A	Landing Width (in)	N/A	N/A	DWS Contrast?	N/A
N/A	Landing Slope (%)	N/A	N/A	DWS Length (in)	N/A
N/A	Landing X Slope (%)	N/A	N/A	DWS Full Width?	N/A
N/A	Landing Curb? (Y/N)	N/A	N/A	DWS Offset (in)	N/A
N/A	Shared Landing?	N/A			
N/A	Gutter Ponding?	N/A	N/A	Gutter Slope (%)	N/A
N/A	Gutter Lip Ht (in)	N/A	N/A	Gutter X Slope (%)	N/A
N/A	Painted X Walk1?	No	N/A	Painted X Walk2?	N/A
	X Walk 1 Direction	To NW		X Walk 2 Direction	N/A
N/A	X Walk 1 Width (in)	N/A	N/A	X Walk 2 Width (in)	N/A
	X Walk 1 Slope (%)	6.5		X Walk 2 Slope (%)	N/A
	X Walk 1 X Slope (%)	1.1		X Walk 2 X Slope (%)	N/A

N/A	Ramp inside XWalk1?	N/A	N/A	Ramp inside XWalk2?	N/A
	Road Slope (%)	N/A	N/A	Clear Space?	N/A
	Road X Slope (%)	N/A	N/A	Clear Space to XWalk (in)	N/A
N/A	Any Obstructions?	N/A	N/A	Storm Grate/Utility Hazard?	N/A
	Obstruction Type			Storm Grate/Utility Type	
		N/A			N/A
		No		Surface Condition? (G/P)	Poor

**Remove & Replace Entire Ramp.**
