Access Compliance Report

Public Rights-of-Way

(Curb Ramps)

Intersection ID: 49273	Main Street: REMINISCE_LN	Cross Street: REUNION_ST	Location:	W
ADA ID: 72E37AE0567A	Ramp Type: Perp	Initial Pass/Fail: Fail	Overall Compliance: No	Severity Score: 25

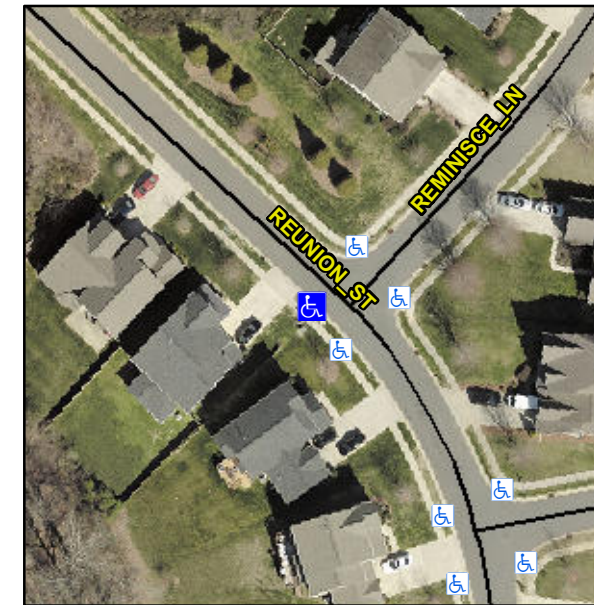
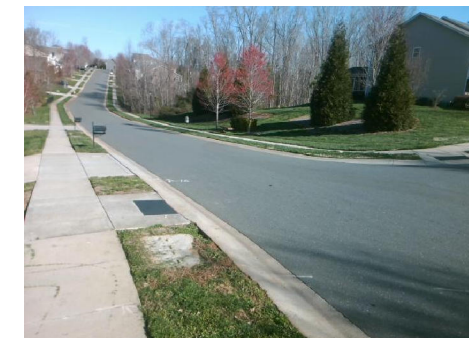
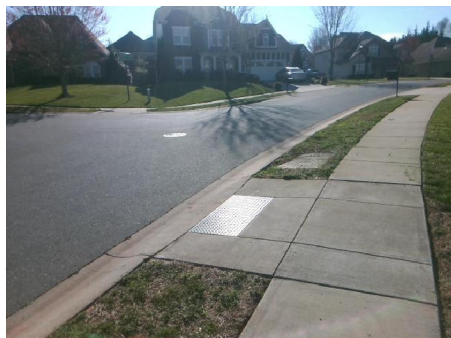
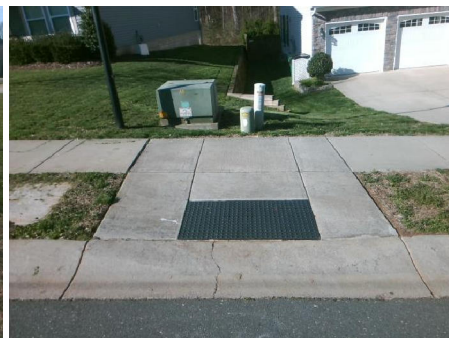
Not Found, R304.5.3

Compliance	Description	Data	Compliance	Description	Data
N/A	Ramp Length (in)	49.0	Yes	Ramp Slope (%)	6.1
Yes	Ramp Width (in)	48.0	No	Ramp XSlope (%)	7.6
N/A	Flare Type LT	N/A	N/A	Flare Type RT	N/A
N/A	Flare Slope LT (%)	N/A	N/A	Flare Slope RT (%)	N/A
N/A	Flare Traversable LT?	N/A	N/A	Flare Traversable RT?	N/A
N/A	Landing Length (in)	N/A	N/A	DWS Provided?	N/A
N/A	Landing Width (in)	N/A	N/A	DWS Contrast?	N/A
N/A	Landing Slope (%)	N/A	N/A	DWS Length (in)	N/A
N/A	Landing X Slope (%)	N/A	N/A	DWS Full Width?	N/A
N/A	Landing Curb? (Y/N)	N/A	N/A	DWS Offset (in)	N/A
N/A	Shared Landing?	N/A			
N/A	Gutter Ponding?	N/A	N/A	Gutter Slope (%)	N/A
N/A	Gutter Lip Ht (in)	N/A	N/A	Gutter X Slope (%)	N/A
N/A	Painted X Walk1?	No	N/A	Painted X Walk2?	N/A
	X Walk 1 Direction	To NE		X Walk 2 Direction	N/A
N/A	X Walk 1 Width (in)	N/A	N/A	X Walk 2 Width (in)	N/A
	X Walk 1 Slope (%)	2.8		X Walk 2 Slope (%)	N/A
	X Walk 1 X Slope (%)	7.6		X Walk 2 X Slope (%)	N/A

Remove & Replace Entire Ramp.
