# Access Compliance Report

## Public Rights-of-Way

### (Curb Ramps)

| Intersection ID: 51181 | Main Street: FIRCREST_DR | Cross Street: WHIPPET_RIDGE_CT | Location: SE |

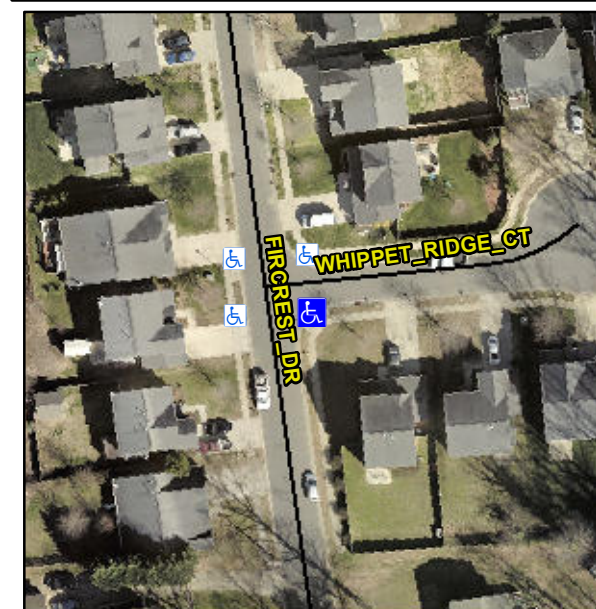
| ADA ID: 72ED5DB39D8A | Ramp Type: PerpDiag | Initial Pass/Fail: Fail | Overall Compliance: No |
| Severity Score: 8.75 | | | |

**R304.5.1**

| Compliance | Description | Data | Compliance | Description | Data |
|---|---|---|---|---|---|
| No | Ramp Width (in) | 45.0 | Yes | Ramp XSlope (%) | 0.1 |

**Remove & Replace Curb Ramp With Two New Directional Ramps or Equivalent.**

Total Cost: \$ 3200.00
