Access Compliance Report

Public Rights-of-Way

(Curb Ramps)

Intersection ID: 29786	Main Street: ELM_LN	Cross Street: MILLWRIGHT_LN	Location: SE
ADA ID: 72F551E62E0E	Ramp Type: PerpDiag	Initial Pass/Fail: Fail	Overall Compliance: No
		Severity Score: 46.25

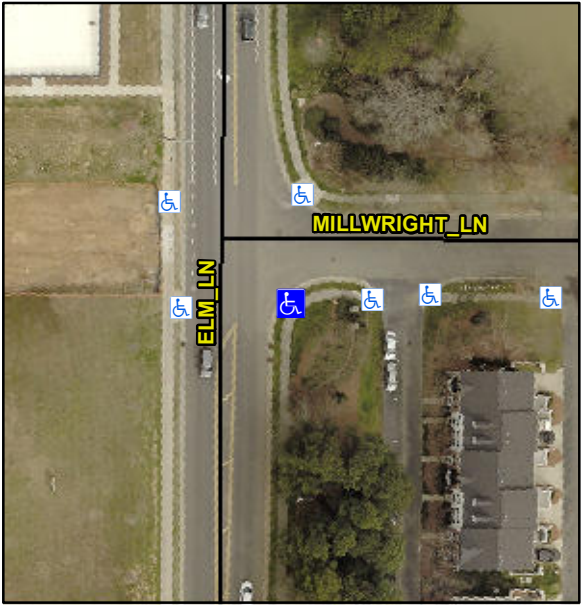
Possible Solutions:		Compliance	Description	Data
	Remove & Replace Curb Ramp With Two New Directional Ramps or Equivalent.		No	Ramp Length (in)	50.0
			No	Ramp Width (in)	42.5
			N/A	Flare Type LT	N/A
			N/A	Flare Slope LT (%)	N/A
			N/A	Flare Traversable LT?	N/A
			N/A	Landing Length (in)	N/A
			N/A	Landing Width (in)	N/A
			N/A	Landing Slope (%)	N/A
			N/A	Landing X Slope (%)	N/A
			N/A	Landing Curb? (Y/N)	N/A
			N/A	Shared Landing?	N/A
			N/A	Gutter Ponding?	N/A
			N/A	Gutter Lip Ht (in)	N/A
			No	Painted X Walk1?	N/A
				X Walk 1 Direction	To W
			N/A	X Walk 1 Width (in)	N/A
				X Walk 1 Slope (%)	4.9
				X Walk 1 X Slope (%)	7.8
			N/A	Ramp inside XWalk1?	N/A
<p>Surveyor Notes:</p> <p>N/A</p> <p>PROW/ADA:</p> <p>R304.5.1, R304.2.2, R304.5.3</p>			N/A	Flare Type RT	N/A
			N/A	Flare Slope RT (%)	N/A
			N/A	Flare Traversable RT?	N/A

N/A	DWS Provided?	N/A
			N/A	DWS Contrast?	N/A
			N/A	DWS Length (in)	N/A
			N/A	DWS Full Width?	N/A
			N/A	DWS Offset (in)	N/A
			N/A	Gutter Slope (%)	N/A
			N/A	Gutter X Slope (%)	N/A
			No	Painted X Walk2?	No
				X Walk 2 Direction	To NE
			N/A	X Walk 2 Width (in)	N/A
				X Walk 2 Slope (%)	6.1
				X Walk 2 X Slope (%)	1.1
			N/A	Ramp inside XWalk2?	N/A
			N/A	Clear Space?	N/A
			N/A	Clear Space to XWalk (in)	N/A
			N/A	Storm Grate/Utility Hazard?	N/A
				Storm Grate/Utility Type	
			N/A		N/A
			Yes	Surface Condition? (G/P)	Good
Street 1 Name	ELM LN				
Stop Condition-Street 2	None				
Street 2 Name	MILLWRIGHT LN				
Stop Condition-Street 1	StopSign				
Total Cost:	\$	3200.00
