# Access Compliance Report

## Public Rights-of-Way (Curb Ramps)

Intersection ID: 9765	Main Street: RUSH_WIND_DR	Cross Street: TINNIN_AV	Location: SE
ADA ID: 7307C22D770F	Ramp Type: Perp	Initial Pass/Fail: Fail	Overall Compliance: No Severity Score: 33.75

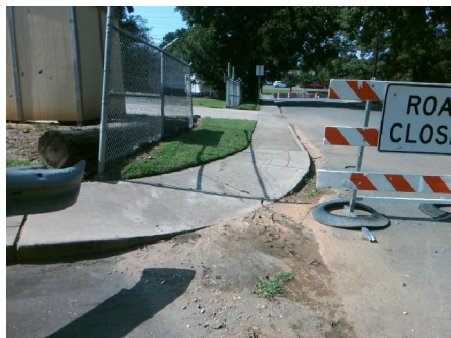
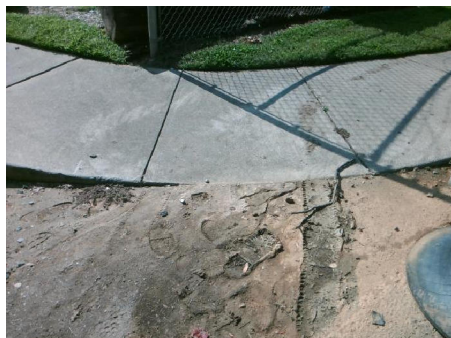
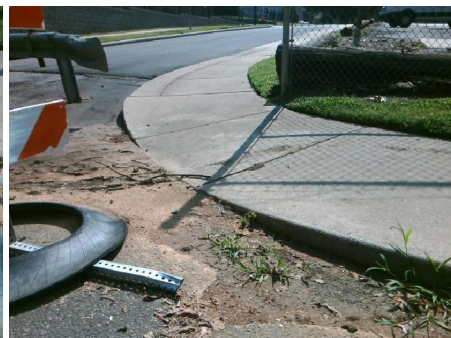
<div>Street 1 Name<div>RUSH WIND DR</div></div> <div>Stop Condition-Street 2<div>None</div></div> <div>Street 2 Name<div>N/A</div></div> <div>Stop Condition-Street 1<div>N/A</div></div>	Possible Solutions:		Compliance	Description	Data	Compliance	Description	Data
	Remove & Replace Entire Ramp.		N/A	Ramp Length (in)	63.5	No	Ramp Slope (%)	13.8
			No	Ramp Width (in)	42.0	Yes	Ramp XSlope (%)	0.1
			N/A	Flare Type LT	N/A	N/A	Flare Type RT	N/A
			N/A	Flare Slope LT (%)	N/A	N/A	Flare Slope RT (%)	N/A
			N/A	Flare Traversable LT?	N/A	N/A	Flare Traversable RT?	N/A
			N/A	Landing Length (in)	N/A	N/A	DWS Provided?	N/A
			N/A	Landing Width (in)	N/A	N/A	DWS Contrast?	N/A
			N/A	Landing Slope (%)	N/A	N/A	DWS Length (in)	N/A
			N/A	Landing X Slope (%)	N/A	N/A	DWS Full Width?	N/A
			N/A	Landing Curb? (Y/N)	N/A	N/A	DWS Offset (in)	N/A

N/A	Shared Landing?	N/A			
			N/A	Gutter Ponding?	N/A	N/A	Gutter Slope (%)	N/A
			N/A	Gutter Lip Ht (in)	N/A	N/A	Gutter X Slope (%)	N/A
			N/A	Painted X Walk1?	No	N/A	Painted X Walk2?	N/A
				X Walk 1 Direction	To W		X Walk 2 Direction	N/A
			N/A	X Walk 1 Width (in)	N/A	N/A	X Walk 2 Width (in)	N/A
				X Walk 1 Slope (%)	1.5		X Walk 2 Slope (%)	N/A
				X Walk 1 X Slope (%)	0.1		X Walk 2 X Slope (%)	N/A
			N/A	Ramp inside XWalk1?	N/A	N/A	Ramp inside XWalk2?	N/A
				Road Slope (%)	N/A	N/A	Clear Space?	N/A
				Road X Slope (%)	N/A	N/A	Clear Space to XWalk (in)	N/A
			N/A	Any Obstructions?	N/A	N/A	Storm Grate/Utility Hazard?	N/A
				Obstruction Type			Storm Grate/Utility Type	
					N/A			N/A
						Yes	Surface Condition? (G/P)	Good
Total Cost:		\$ 1850.00
