Access Compliance Report

Public Rights-of-Way

(Curb Ramps)

Intersection ID: 45835	Main Street: CHRISTENBURY_HILLS_LN	Cross Street: KELDEN_WALKER_LN	Location: NE
ADA ID: 7326BB1FA1BD	Ramp Type: PerpDiag	Initial Pass/Fail: Fail	Overall Compliance: No
Severity Score: 55			
Codes/Mitigation Info/Possible Solution		Field Measurements/Component Compliance

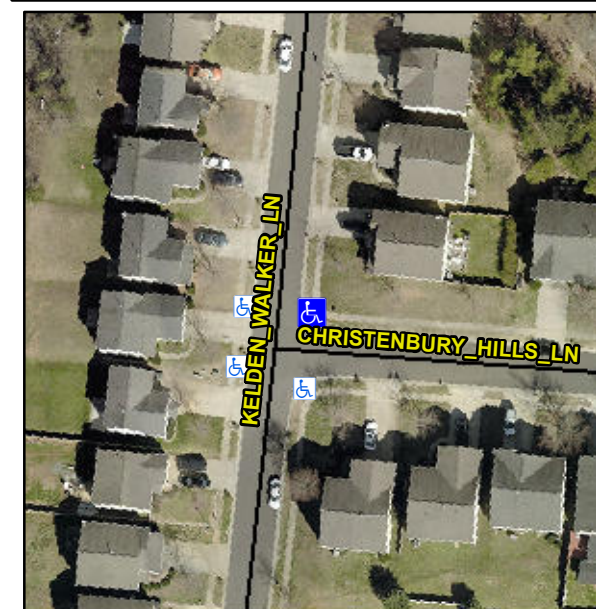
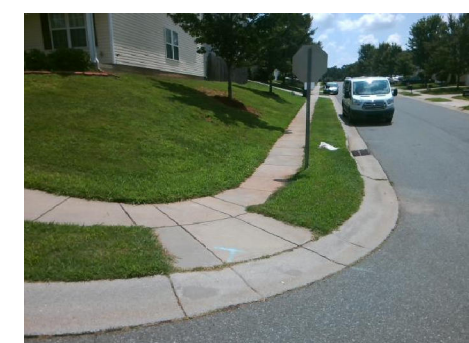
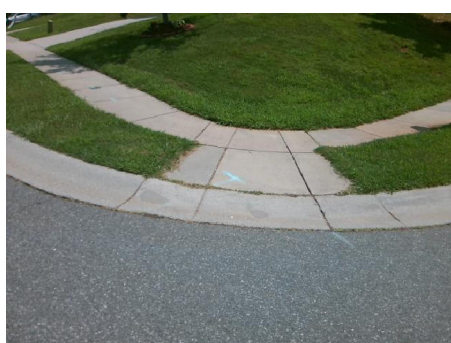
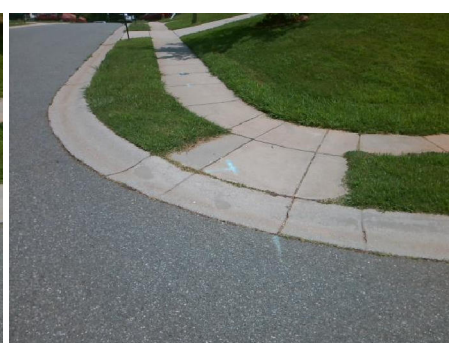
Not Found, R304.5.1, R304.2.2, R304.5.3

Compliance	Description	Data	Compliance	Description	Data
N/A	Ramp Length (in)	47.0	No	Ramp Slope (%)	10.5
No	Ramp Width (in)	33.0	No	Ramp XSlope (%)	8.8
N/A	Flare Type LT	N/A	N/A	Flare Type RT	N/A
N/A	Flare Slope LT (%)	N/A	N/A	Flare Slope RT (%)	N/A
N/A	Flare Traversable LT?	N/A	N/A	Flare Traversable RT?	N/A
N/A	Landing Length (in)	N/A	N/A	DWS Provided?	N/A
N/A	Landing Width (in)	N/A	N/A	DWS Contrast?	N/A
N/A	Landing Slope (%)	N/A	N/A	DWS Length (in)	N/A
N/A	Landing X Slope (%)	N/A	N/A	DWS Full Width?	N/A
N/A	Landing Curb? (Y/N)	N/A	N/A	DWS Offset (in)	N/A
N/A	Shared Landing?	N/A			
N/A	Gutter Ponding?	N/A	N/A	Gutter Slope (%)	N/A
N/A	Gutter Lip Ht (in)	N/A	N/A	Gutter X Slope (%)	N/A
N/A	Painted X Walk1?	No	N/A	Painted X Walk2?	No
	X Walk 1 Direction	To W		X Walk 2 Direction	To S
N/A	X Walk 1 Width (in)	N/A	N/A	X Walk 2 Width (in)	N/A
	X Walk 1 Slope (%)	1.0		X Walk 2 Slope (%)	5.0
	X Walk 1 X Slope (%)	8.9		X Walk 2 X Slope (%)	0.8

N/A	Ramp inside XWalk1?	N/A	N/A	Ramp inside XWalk2?	N/A
	Road Slope (%)	6.4	N/A	Clear Space?	N/A
	Road X Slope (%)	3.1	N/A	Clear Space to XWalk (in)	N/A
N/A	Any Obstructions?	N/A	N/A	Storm Grate/Utility Hazard?	N/A
	Obstruction Type			Storm Grate/Utility Type	
		N/A			N/A
			Yes	Surface Condition? (G/P)	Good

Remove & Replace Curb Ramp With Two New Directional Ramps or Equivalent.
