Access Compliance Report

Public Rights-of-Way

(Curb Ramps)

Intersection ID: 11882	Main Street: N_PINE_ST	Cross Street: W_5TH_ST	Location: S
ADA ID: 7336A06B4588	Ramp Type: Perp	Initial Pass/Fail: Fail	Overall Compliance: No
		Severity Score: 12.5

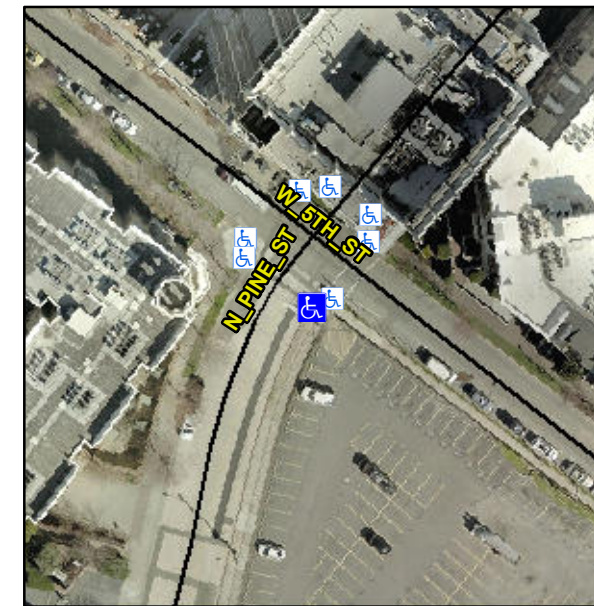
Not Found, R304.2.2

Compliance	Description	Data	Compliance	Description	Data
N/A	Ramp Length (in)	63.0	No	Ramp Slope (%)	9.0
Yes	Ramp Width (in)	51.0	Yes	Ramp XSlope (%)	0.5
N/A	Flare Type LT	N/A	N/A	Flare Type RT	N/A
N/A	Flare Slope LT (%)	N/A	N/A	Flare Slope RT (%)	N/A
N/A	Flare Traversable LT?	N/A	N/A	Flare Traversable RT?	N/A
N/A	Landing Length (in)	N/A	N/A	DWS Provided?	N/A
N/A	Landing Width (in)	N/A	N/A	DWS Contrast?	N/A
N/A	Landing Slope (%)	N/A	N/A	DWS Length (in)	N/A
N/A	Landing X Slope (%)	N/A	N/A	DWS Full Width?	N/A
N/A	Landing Curb? (Y/N)	N/A	N/A	DWS Offset (in)	N/A
N/A	Shared Landing?	N/A			
N/A	Gutter Ponding?	N/A	N/A	Gutter Slope (%)	N/A
N/A	Gutter Lip Ht (in)	N/A	N/A	Gutter X Slope (%)	N/A
N/A	Painted X Walk1?	Yes	N/A	Painted X Walk2?	N/A
	X Walk 1 Direction	To NW		X Walk 2 Direction	N/A
N/A	X Walk 1 Width (in)	99.0	N/A	X Walk 2 Width (in)	N/A
	X Walk 1 Slope (%)	0.1		X Walk 2 Slope (%)	N/A
	X Walk 1 X Slope (%)	2.7		X Walk 2 X Slope (%)	N/A

N/A	Ramp inside XWalk1?	Yes	N/A	Ramp inside XWalk2?	N/A
	Road Slope (%)	N/A	N/A	Clear Space?	N/A
	Road X Slope (%)	N/A	N/A	Clear Space to XWalk (in)	N/A
N/A	Any Obstructions?	N/A	N/A	Storm Grate/Utility Hazard?	N/A
	Obstruction Type			Storm Grate/Utility Type	
		N/A			N/A
			Yes	Surface Condition? (G/P)	Good

Remove & Replace Entire Ramp.

Total Cost: \$ 1850.00
