Access Compliance Report Public Rights-of-Way (Curb Ramps)

Intersection ID: 14839 Main Street: BEULAH AV Cross Street: W TYVOLA RD Location:

ADA ID: 7339EAC24E02 Ramp Type: PerpDiag Initial Pass/Fail: Fail **Overall Compliance: No** Severity Score: 58.75

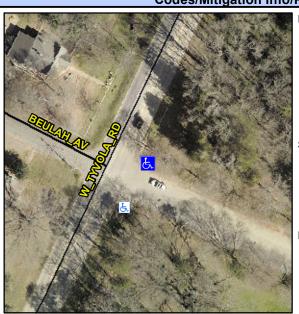
ried Measurements/Component Comphance						
	Compliance Description		Data	Compliance Description		Data
	N/A	Ramp Length (in)	54.0	No	Ramp Slope (%)	15.8
	No	Ramp Width (in)	46.0	No	Ramp XSlope (%)	7.0
	N/A	Flare Type LT	N/A	N/A	Flare Type RT	N/A
	N/A	Flare Slope LT (%)	N/A	N/A	Flare Slope RT (%)	N/A
	N/A	Flare Traversable LT?	N/A	N/A	Flare Traversable RT?	N/A
	N/A	Landing Length (in)	N/A	N/A	DWS Provided?	N/A
	N/A	Landing Width (in)	N/A	N/A	DWS Contrast?	N/A
	N/A	Landing Slope (%)	N/A	N/A	DWS Length (in)	N/A
	N/A	Landing X Slope (%)	N/A	N/A	DWS Full Width?	N/A
	N/A	Landing Curb? (Y/N)	N/A	N/A	DWS Offset (in)	N/A
	N/A	Shared Landing?	N/A			
	N/A	Gutter Ponding?	N/A	N/A	Gutter Slope (%)	N/A
	N/A	Gutter Lip Ht (in)	N/A	N/A	Gutter X Slope (%)	N/A
	N/A	Painted X Walk1?	No	N/A	Painted X Walk2?	No
		X Walk 1 Direction	To NW		X Walk 2 Direction	To SW
	N/A	X Walk 1 Width (in)	N/A	N/A	X Walk 2 Width (in)	N/A
		X Walk 1 Slope (%)	1.3		X Walk 2 Slope (%)	1.1

X Walk 1 X Slope (%)	1.2		X Walk 2 X Slope (%)	3.9
	N/A	Ramp inside XWalk1?	N/A	N/A	Ramp inside XWalk2?	N/A
		Road Slope (%)	4.4	N/A	Clear Space?	N/A
		Road X Slope (%)	0.7	N/A	Clear Space to XWalk (in)	N/A
	N/A	Any Obstructions?	N/A	N/A	Storm Grate/Utility Hazard?	N/A

Possible Solutions: Remove & Replace Curb Ramp With Two New Directional Ramps or Equivalent. Surveyor Notes: N/A PROW/ADA: R304.5.1, R304.2.2, R304.5.3
