# Access Compliance Report

## Public Rights-of-Way

### (Curb Ramps)

Intersection ID: 26367	Main Street: BEVINGTON_PL	Cross Street: GLYNMOOR_LAKES_DR	Location: SE
ADA ID: 7376759A592E	Ramp Type: PerpDiag	Initial Pass/Fail: Fail	Overall Compliance: No
Codes/Mitigation Info/Possible Solution		Field Measurements/Component Compliance	
Severity Score: 18.75

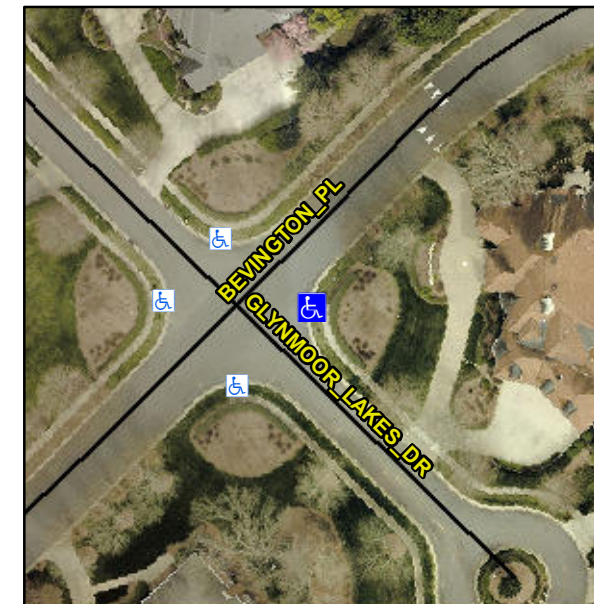
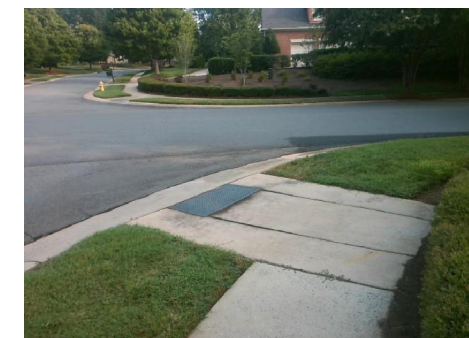
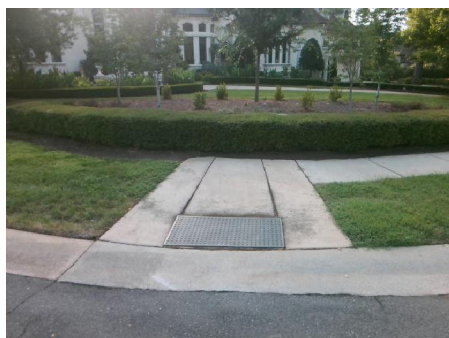
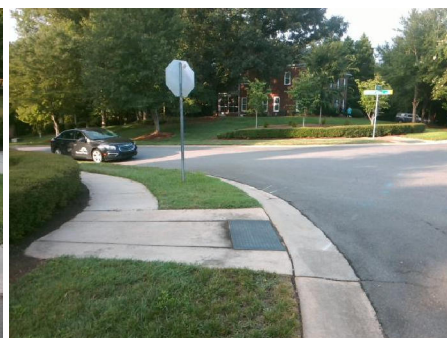
Compliance	Description	Data	Compliance	Description	Data
N/A	Ramp Length (in)	119.0	Yes	Ramp Slope (%)	6.3
No	Ramp Width (in)	33.0	No	Ramp XSlope (%)	2.5
N/A	Flare Type LT	N/A	N/A	Flare Type RT	N/A
N/A	Flare Slope LT (%)	N/A	N/A	Flare Slope RT (%)	N/A
N/A	Flare Traversable LT?	N/A	N/A	Flare Traversable RT?	N/A
N/A	Landing Length (in)	N/A	N/A	DWS Provided?	N/A
N/A	Landing Width (in)	N/A	N/A	DWS Contrast?	N/A
N/A	Landing Slope (%)	N/A	N/A	DWS Length (in)	N/A
N/A	Landing X Slope (%)	N/A	N/A	DWS Full Width?	N/A
N/A	Landing Curb? (Y/N)	N/A	N/A	DWS Offset (in)	N/A
N/A	Shared Landing?	N/A			
N/A	Gutter Ponding?	N/A	N/A	Gutter Slope (%)	N/A
N/A	Gutter Lip Ht (in)	N/A	N/A	Gutter X Slope (%)	N/A
N/A	Painted X Walk1?	No	N/A	Painted X Walk2?	No
	X Walk 1 Direction	To NW		X Walk 2 Direction	To SW
N/A	X Walk 1 Width (in)	N/A	N/A	X Walk 2 Width (in)	N/A
	X Walk 1 Slope (%)	4.0		X Walk 2 Slope (%)	0.8
	X Walk 1 X Slope (%)	1.1		X Walk 2 X Slope (%)	1.9

N/A	Ramp inside XWalk1?	N/A	N/A	Ramp inside XWalk2?	N/A
	Road Slope (%)	0.7	N/A	Clear Space?	N/A
	Road X Slope (%)	1.2	N/A	Clear Space to XWalk (in)	N/A
N/A	Any Obstructions?	N/A	N/A	Storm Grate/Utility Hazard?	N/A
	Obstruction Type			Storm Grate/Utility Type	
		N/A			N/A
		Yes		Surface Condition? (G/P)	Good

**Remove & Replace Curb Ramp With Two New Directional Ramps or Equivalent.**

**R304.5.1, R304.5.3**
