## Access Compliance Report Public Rights-of-Way (Curb Ramps)

Intersection ID: 44213 Main Street: GOLDEN\_APPLE\_CT Cross Street: MOCKERNUT\_DR Location: S

ADA ID: 7378F21AE83F Ramp Type: Perp Initial Pass/Fail: Fail Overall Compliance: No Severity Score: 21.25

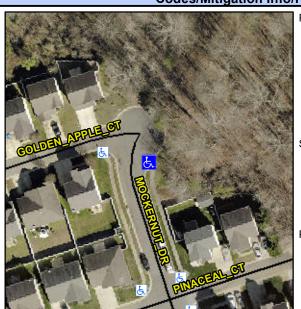
Possible Solutions:	_	
Remove & Replace Entire Ramp.		
•	N	
	N	
	N	
	N	
	N	
Surveyor Notes:	N	
N/A	N	
	N	
	N	
	N	
PROW/ADA:	N	
Not Found, R304.5.1, R304.5.3	N	
	N	
	N

Compl	iance Description	Data		liance Description	Data
N/A	Ramp Length (in)	48.5	Yes	Ramp Slope (%)	7.9
No	Ramp Width (in)	47.5	No	Ramp XSlope (%)	5.6
N/A	Flare Type LT	N/A	N/A	Flare Type RT	N/A
N/A	Flare Slope LT (%)	N/A	N/A	Flare Slope RT (%)	N/A
N/A	Flare Traversable LT?	N/A	N/A	Flare Traversable RT?	N/A
N/A	Landing Length (in)	N/A	N/A	DWS Provided?	N/A
N/A	Landing Width (in)	N/A	N/A	DWS Contrast?	N/A
N/A	Landing Slope (%)	N/A	N/A	DWS Length (in)	N/A
N/A	Landing X Slope (%)	N/A	N/A	DWS Full Width?	N/A
N/A	Landing Curb? (Y/N)	N/A	N/A	DWS Offset (in)	N/A
N/A	Shared Landing?	N/A			
N/A	Gutter Ponding?	N/A	N/A	Gutter Slope (%)	N/A
N/A	Gutter Lip Ht (in)	N/A	N/A	Gutter X Slope (%)	N/A
N/A	Painted X Walk1?	No	N/A	Painted X Walk2?	N/A
	X Walk 1 Direction	To NW		X Walk 2 Direction	N/A
N/A	X Walk 1 Width (in)	N/A	N/A	X Walk 2 Width (in)	N/A
	X Walk 1 Slope (%)	0.9		X Walk 2 Slope (%)	N/A
	X Walk 1 X Slope (%)	4.0		X Walk 2 X Slope (%)	N/A

N/A	Ramp inside XWalk1?	N/A	N/A	Ramp inside XWalk2?	N/A
	Road Slope (%)	N/A	N/A	Clear Space?	N/A
	Road X Slope (%)	N/A	N/A	Clear Space to XWalk (in)	N/A
N/A	Any Obstructions?	N/A	N/A	Storm Grate/Utility Hazard?	N/A
	Obstruction Type		l	Storm Grate/Utility Type	
		N/A			N/A
			Yes	Surface Condition? (G/P)	Good

1850.00
