Access Compliance Report

Public Rights-of-Way

(Curb Ramps)

Intersection ID: 15515	Main Street: BERKSHIRE_RD	Cross Street: LAWDALE_RD	Location: W
ADA ID: 737E1960BDF4	Ramp Type: PerpDiag	Initial Pass/Fail: Fail	Overall Compliance: No
Codes/Mitigation Info/Possible Solution		Field Measurements/Component Compliance

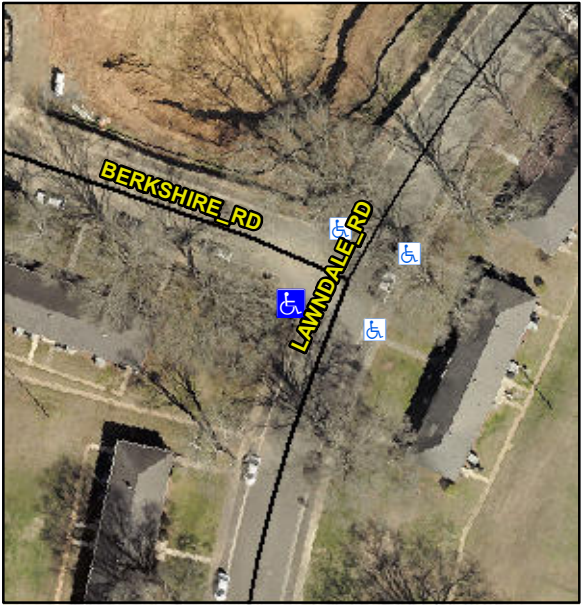
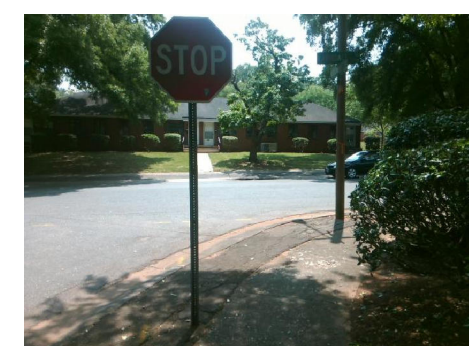
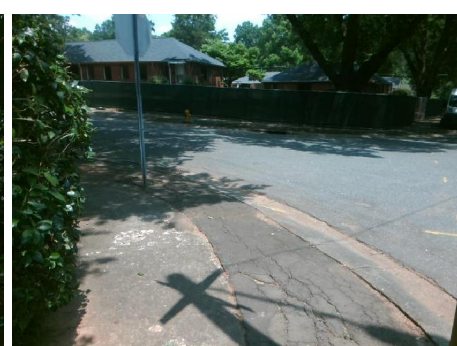
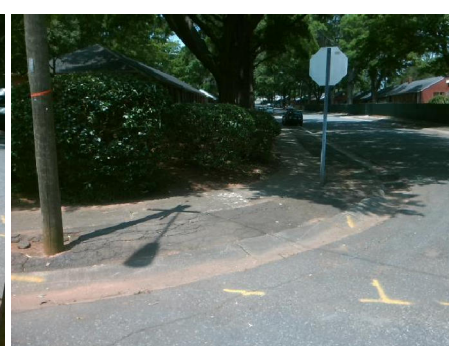
Possible Solutions:	Compliance	Description	Data	Compliance	Description	Data
	Remove & Replace Curb Ramp With Two New Directional Ramps or Equivalent.	N/A	Ramp Length (in)	62.0	No	Ramp Slope (%)	15.0
<p>Surveyor Notes:</p> <p>N/A</p> <p>PROW/ADA:</p> <p>Not Found, R304.5.1, R304.2.2, R304.5.3, R302.7</p>		No	Ramp Width (in)	46.0	No	Ramp XSlope (%)	5.4
		N/A	Flare Type LT	N/A	N/A	Flare Type RT	N/A
		N/A	Flare Slope LT (%)	N/A	N/A	Flare Slope RT (%)	N/A
		N/A	Flare Traversable LT?	N/A	N/A	Flare Traversable RT?	N/A
		N/A	Landing Length (in)	N/A	N/A	DWS Provided?	N/A
		N/A	Landing Width (in)	N/A	N/A	DWS Contrast?	N/A
		N/A	Landing Slope (%)	N/A	N/A	DWS Length (in)	N/A
		N/A	Landing X Slope (%)	N/A	N/A	DWS Full Width?	N/A
		N/A	Landing Curb? (Y/N)	N/A	N/A	DWS Offset (in)	N/A
		N/A	Shared Landing?	N/A			
		N/A	Gutter Ponding?	N/A	N/A	Gutter Slope (%)	N/A
		N/A	Gutter Lip Ht (in)	N/A	N/A	Gutter X Slope (%)	N/A

N/A	Painted X Walk1?	No	N/A	Painted X Walk2?	No
			X Walk 1 Direction	To SE		X Walk 2 Direction	To NE
		N/A	X Walk 1 Width (in)	N/A	N/A	X Walk 2 Width (in)	N/A
			X Walk 1 Slope (%)	2.8		X Walk 2 Slope (%)	0.4
			X Walk 1 X Slope (%)	0.7		X Walk 2 X Slope (%)	1.2
		N/A	Ramp inside XWalk1?	N/A	N/A	Ramp inside XWalk2?	N/A
			Road Slope (%)	0.9	N/A	Clear Space?	N/A
			Road X Slope (%)	2.4	N/A	Clear Space to XWalk (in)	N/A
		N/A	Any Obstructions?	N/A	N/A	Storm Grate/Utility Hazard?	N/A
			Obstruction Type			Storm Grate/Utility Type	
				N/A			N/A
				No		Surface Condition? (G/P)	Poor
Total Cost:		\$	3200.00
