Access Compliance Report

Public Rights-of-Way

(Curb Ramps)

Intersection ID: 3396	Main Street: BRANDY_RIDGE_LN	Cross Street: CANIPE_DR	Location: S
ADA ID: 73A6E5BBD167	Ramp Type: PerpDiag	Initial Pass/Fail: Fail	Overall Compliance: No
		Severity Score: 10

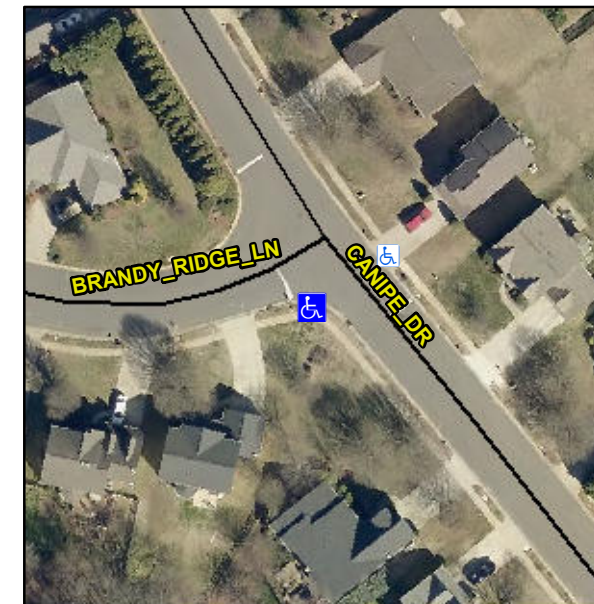
Not Found, R304.5.1, R304.5.3

Compliance	Description	Data	Compliance	Description	Data
N/A	Ramp Length (in)	48.5	Yes	Ramp Slope (%)	6.2
No	Ramp Width (in)	43.0	No	Ramp XSlope (%)	4.3
N/A	Flare Type LT	N/A	N/A	Flare Type RT	N/A
N/A	Flare Slope LT (%)	N/A	N/A	Flare Slope RT (%)	N/A
N/A	Flare Traversable LT?	N/A	N/A	Flare Traversable RT?	N/A
N/A	Landing Length (in)	N/A	N/A	DWS Provided?	N/A
N/A	Landing Width (in)	N/A	N/A	DWS Contrast?	N/A
N/A	Landing Slope (%)	N/A	N/A	DWS Length (in)	N/A
N/A	Landing X Slope (%)	N/A	N/A	DWS Full Width?	N/A
N/A	Landing Curb? (Y/N)	N/A	N/A	DWS Offset (in)	N/A
N/A	Shared Landing?	N/A			
N/A	Gutter Ponding?	N/A	N/A	Gutter Slope (%)	N/A
N/A	Gutter Lip Ht (in)	N/A	N/A	Gutter X Slope (%)	N/A
N/A	Painted X Walk1?	No	N/A	Painted X Walk2?	No
	X Walk 1 Direction	To NW		X Walk 2 Direction	To NE
N/A	X Walk 1 Width (in)	N/A	N/A	X Walk 2 Width (in)	N/A
	X Walk 1 Slope (%)	3.2		X Walk 2 Slope (%)	2.2
	X Walk 1 X Slope (%)	4.2		X Walk 2 X Slope (%)	3.9

N/A	Ramp inside XWalk1?	N/A	N/A	Ramp inside XWalk2?	N/A
	Road Slope (%)	2.9	N/A	Clear Space?	N/A
	Road X Slope (%)	4.0	N/A	Clear Space to XWalk (in)	N/A
N/A	Any Obstructions?	N/A	N/A	Storm Grate/Utility Hazard?	N/A
	Obstruction Type			Storm Grate/Utility Type	
		N/A			N/A
			Yes	Surface Condition? (G/P)	Good

Remove & Replace Curb Ramp With Two New Directional Ramps or Equivalent.
