Access Compliance Report

Public Rights-of-Way

(Curb Ramps)

Intersection ID: 51323	Main Street: GLENMORE_GARDEN_DR	Cross Street: MCKEE_RD	Location: NE
ADA ID: 73B4F7FDC139	Ramp Type: Perp	Initial Pass/Fail: Fail	Overall Compliance: No
Severity Score: 8.75			
Codes/Mitigation Info/Possible Solution		Field Measurements/Component Compliance

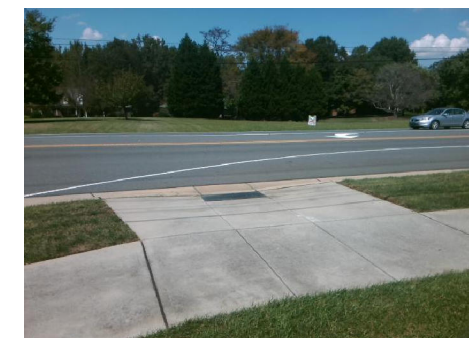
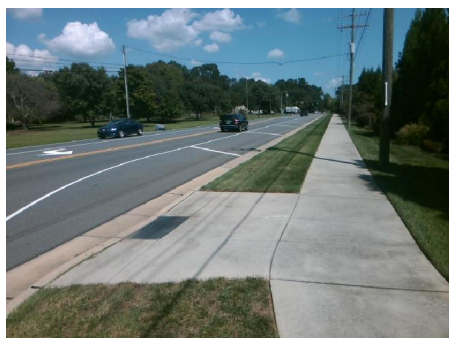
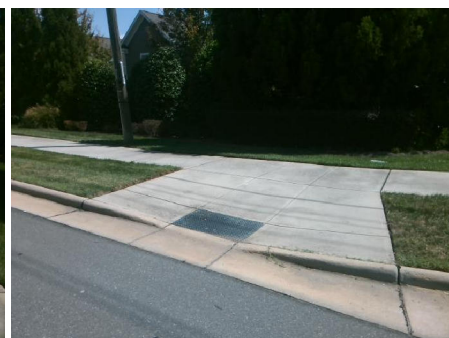
Not Found, R304.5.1

Compliance	Description	Data	Compliance	Description	Data
N/A	Ramp Length (in)	96.0	Yes	Ramp Slope (%)	6.1
No	Ramp Width (in)	45.0	Yes	Ramp XSlope (%)	2.0
N/A	Flare Type LT	N/A	N/A	Flare Type RT	N/A
N/A	Flare Slope LT (%)	N/A	N/A	Flare Slope RT (%)	N/A
N/A	Flare Traversable LT?	N/A	N/A	Flare Traversable RT?	N/A
N/A	Landing Length (in)	N/A	N/A	DWS Provided?	N/A
N/A	Landing Width (in)	N/A	N/A	DWS Contrast?	N/A
N/A	Landing Slope (%)	N/A	N/A	DWS Length (in)	N/A
N/A	Landing X Slope (%)	N/A	N/A	DWS Full Width?	N/A
N/A	Landing Curb? (Y/N)	N/A	N/A	DWS Offset (in)	N/A
N/A	Shared Landing?	N/A			
N/A	Gutter Ponding?	N/A	N/A	Gutter Slope (%)	N/A
N/A	Gutter Lip Ht (in)	N/A	N/A	Gutter X Slope (%)	N/A
N/A	Painted X Walk1?	No	N/A	Painted X Walk2?	N/A
	X Walk 1 Direction	To NW		X Walk 2 Direction	N/A
N/A	X Walk 1 Width (in)	N/A	N/A	X Walk 2 Width (in)	N/A
	X Walk 1 Slope (%)	2.2		X Walk 2 Slope (%)	N/A
	X Walk 1 X Slope (%)	1.3		X Walk 2 X Slope (%)	N/A

N/A	Ramp inside XWalk1?	N/A	N/A	Ramp inside XWalk2?	N/A
	Road Slope (%)	N/A	N/A	Clear Space?	N/A
	Road X Slope (%)	N/A	N/A	Clear Space to XWalk (in)	N/A
N/A	Any Obstructions?	N/A	N/A	Storm Grate/Utility Hazard?	N/A
	Obstruction Type			Storm Grate/Utility Type	
		N/A			N/A
			Yes	Surface Condition? (G/P)	Good

Remove & Replace Entire Ramp.
