# Access Compliance Report

## Public Rights-of-Way

### (Curb Ramps)

| Intersection ID: 50744 | Main Street: MERRYVALE_FOREST_DR | Cross Street: PAWTUCKETT_RD | Location: E |

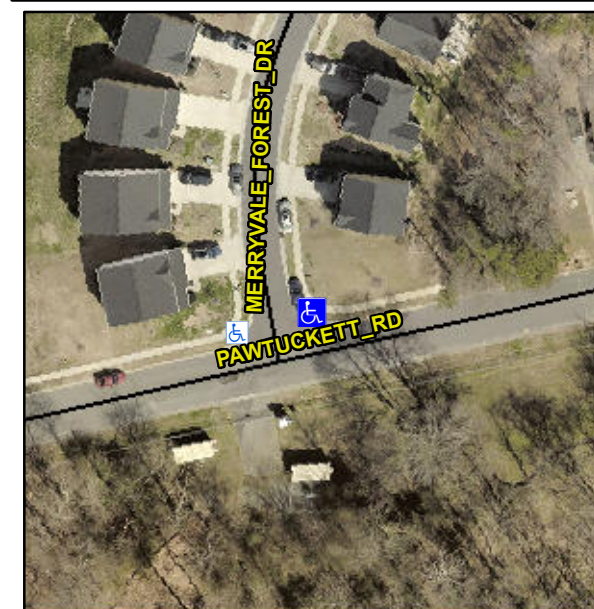
| ADA ID: 73BB3CE3FA22 | Ramp Type: Perp | Initial Pass/Fail: Fail | Overall Compliance: No |
| Severity Score: 8.75 | | | |

**Not Found, R304.5.1**

| Compliance | Description | Data | Compliance | Description | Data |
|---|---|---|---|---|---|
| No | Ramp Width (in) | 47.5 | Yes | Ramp XSlope (%) | 1.0 |

**Remove & Replace Entire Ramp.**

Total Cost: \$ 1850.00
