Access Compliance Report

Public Rights-of-Way

(Curb Ramps)

Intersection ID: 48569	Main Street: RED_SQUIRREL_TL	Cross Street: SALAMANDER_RUN_LN	Location: SE
ADA ID: 73BC8BC927AA	Ramp Type: BlendTrans1	Initial Pass/Fail: Pass	Overall Compliance: No
Severity Score: 0			
Codes/Mitigation Info/Possible Solution		Field Measurements/Component Compliance

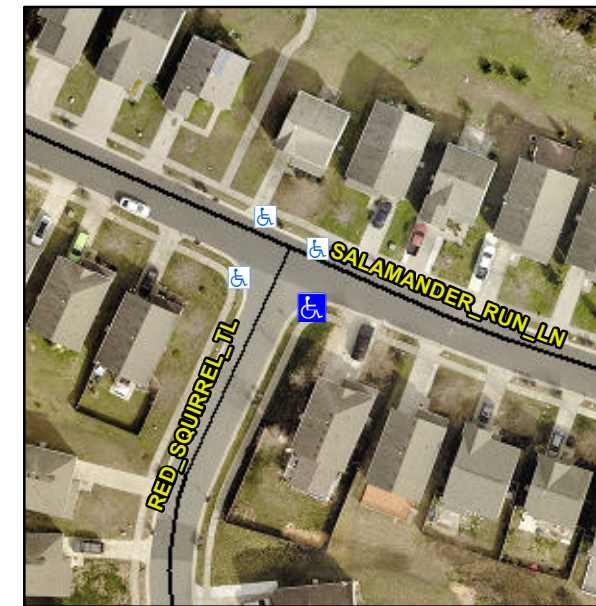
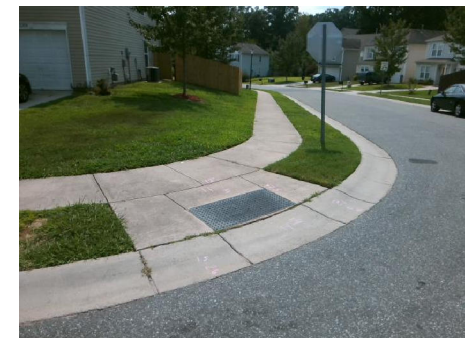
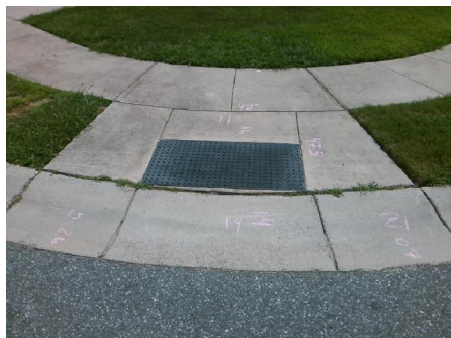
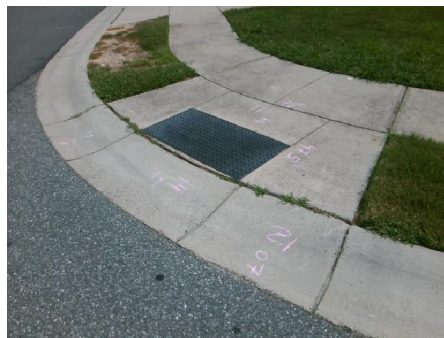
Not Found, R304.2.1

Compliance	Description	Data	Compliance	Description	Data
N/A	Ramp Length (in)	47.5	Yes	BlendTrans Slope (%)	4.4
Yes	Ramp Width (in)	48.0	Yes	BlendTrans XSlope (%)	1.1
N/A	Flare Type LT	Sloped	N/A	Flare Type RT	Sloped
N/A	Flare Slope LT (%)	0.9	N/A	Flare Slope RT (%)	0.5
N/A	Flare Traversable LT?	No	N/A	Flare Traversable RT?	No
No	Landing Length (in)	46.0	Yes	DWS Provided?	Yes
Yes	Landing Width (in)	77.0	Yes	DWS Contrast?	Yes
Yes	Landing Slope (%)	2.0	Yes	DWS Length (in)	24.5
Yes	Landing X Slope (%)	1.4	Yes	DWS Full Width?	Yes
N/A	Landing Curb? (Y/N)	No	Yes	DWS Offset (in)	1.0
N/A	Shared Landing?	No			
Yes	Gutter Ponding?	No	Yes	Gutter Slope (%)	4.8
Yes	Gutter Lip Ht (in)	0.0	Yes	Gutter X Slope (%)	1.2
N/A	Painted X Walk1?	No	N/A	Painted X Walk2?	No
	X Walk 1 Direction	To N		X Walk 2 Direction	To W
	X Walk 1 Width (in)	N/A		X Walk 2 Width (in)	N/A
	X Walk 1 Slope (%)	2.6		X Walk 2 Slope (%)	0.7
	X Walk 1 X Slope (%)	1.5		X Walk 2 X Slope (%)	2.1

N/A	Ramp inside XWalk1?	N/A	N/A	Ramp inside XWalk2?	N/A
	Road Slope (%)	1.4		Clear Space?	Yes
	Road X Slope (%)	1.4	N/A	Clear Space to XWalk (in)	N/A
Yes	Any Obstructions?	No	Yes	Storm Grate/Utility Hazard?	No
	Obstruction Type			Storm Grate/Utility Type	
		N/A			N/A
			Yes	Surface Condition? (G/P)	Good
			No	Curb Slope (%)	18.3

Possible Solutions:

Remove & Replace Curb Ramp With Two New Directional Ramps or Equivalent.

Total Cost: \$ 3200.00
