Access Compliance Report Public Rights-of-Way (Curb Ramps)

Main Street: PPC DR **Cross Street: CRAVEN THOMAS RD** Intersection ID: 53374 Location: NW ADA ID: 73C29B618C24 **Overall Compliance: No** 10 Ramp Type: Perp Initial Pass/Fail: Fail **Severity Score:**

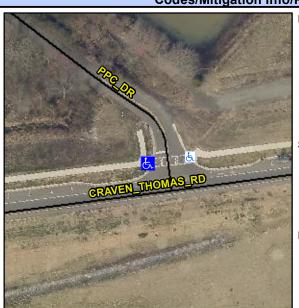
71 OSSIBIC OCIULION		i icia ivic
Possible Solutions:	Compl	liance Description
Remove & Replace Entire Ramp.	N/A	Ramp Length (in)
· ·	No	Ramp Width (in)
	N/A	Flare Type LT
	N/A	Flare Slope LT (%)
	N/A	Flare Traversable L
	N/A	Landing Length (in)
Surveyor Notes:	N/A	Landing Width (in)
N/A	N/A	Landing Slope (%)
	N/A	Landing X Slope (%
	N/A	Landing Curb? (Y/N
	N/A	Shared Landing?
PROW/ADA:	N/A	Gutter Ponding?
R304.5.1, R304.5.3	N/A	Gutter Lip Ht (in)
	N/A	Painted X Walk1?
		X Walk 1 Direction
	N/A	X Walk 1 Width (in)
		X Walk 1 Slope (%)
		X Walk 1 X Slope (%
	N/A	Ramp inside XWalk
		D 101 (0/)

No Ramp XSlope (%) Ramp Width (in) 47.0 3.8 N/A Flare Type LT N/A Flare Type RT N/A Flare Slope LT (%) N/A N/A Flare Slope RT (%) N/A Flare Traversable LT? N/A N/A Flare Traversable RT? N/A Landing Length (in) N/A N/A DWS Provided? N/A Landing Width (in) N/A N/A **DWS Contrast?** N/A N/A N/A Landing Slope (%) DWS Length (in) N/A Landing X Slope (%) N/A N/A DWS Full Width? N/A Landing Curb? (Y/N) N/A N/A DWS Offset (in) N/A N/A Shared Landing? **Gutter Ponding?** N/A N/A Gutter Slope (%) N/A Gutter Lip Ht (in) N/A N/A Gutter X Slope (%) N/A Painted X Walk1? Yes N/A Painted X Walk2? N/A X Walk 1 Direction To E X Walk 2 Direction N/A X Walk 1 Width (in) 97.5 N/A X Walk 2 Width (in) N/A X Walk 1 Slope (%) 0.5 X Walk 2 Slope (%) N/A X Walk 1 X Slope (%) 5.2 X Walk 2 X Slope (%) N/A Ramp inside XWalk1? N/A Ramp inside XWalk2? Yes N/A Road Slope (%) N/A N/A Clear Space? N/A N/A Road X Slope (%) N/A Clear Space to XWalk (in) N/A Any Obstructions? N/A N/A N/A Storm Grate/Utility Hazard? N/A **Obstruction Type** Storm Grate/Utility Type N/A N/A
