Access Compliance Report

Public Rights-of-Way

(Curb Ramps)

Intersection ID: 47915	Main Street: ROOK_RD	Cross Street: OAKDALE_RD	Location:	N
ADA ID: 73C7565B06DD	Ramp Type: Perp	Initial Pass/Fail: Fail	Overall Compliance: No	Severity Score: 12.5
Codes/Mitigation Info/Possible Solution		Field Measurements/Component Compliance

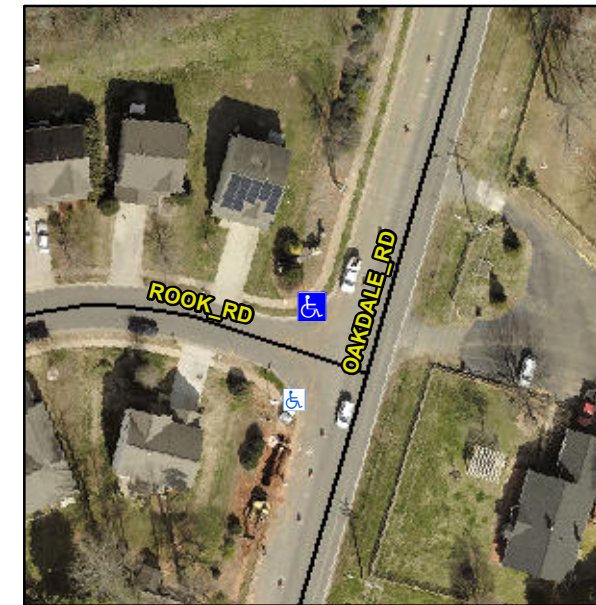
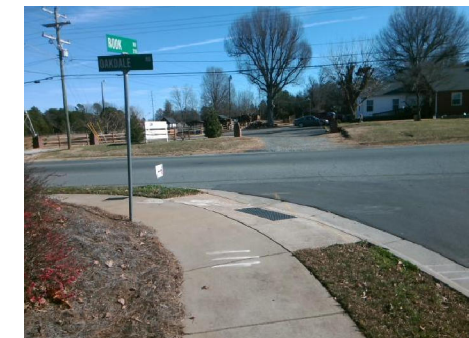
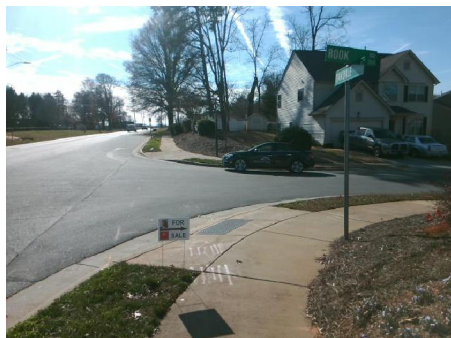
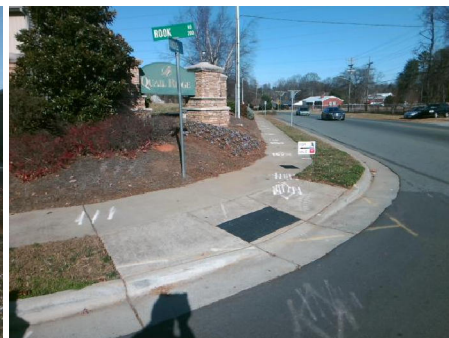
Not Found, R304.2.2

Compliance	Description	Data	Compliance	Description	Data
N/A	Ramp Length (in)	49.0	No	Ramp Slope (%)	11.2
Yes	Ramp Width (in)	48.0	Yes	Ramp XSlope (%)	1.3
N/A	Flare Type LT	N/A	N/A	Flare Type RT	N/A
N/A	Flare Slope LT (%)	N/A	N/A	Flare Slope RT (%)	N/A
N/A	Flare Traversable LT?	N/A	N/A	Flare Traversable RT?	N/A
N/A	Landing Length (in)	N/A	N/A	DWS Provided?	N/A
N/A	Landing Width (in)	N/A	N/A	DWS Contrast?	N/A
N/A	Landing Slope (%)	N/A	N/A	DWS Length (in)	N/A
N/A	Landing X Slope (%)	N/A	N/A	DWS Full Width?	N/A
N/A	Landing Curb? (Y/N)	N/A	N/A	DWS Offset (in)	N/A
N/A	Shared Landing?	N/A			
N/A	Gutter Ponding?	N/A	N/A	Gutter Slope (%)	N/A
N/A	Gutter Lip Ht (in)	N/A	N/A	Gutter X Slope (%)	N/A
N/A	Painted X Walk1?	No	N/A	Painted X Walk2?	N/A
	X Walk 1 Direction	To SW		X Walk 2 Direction	N/A
N/A	X Walk 1 Width (in)	N/A	N/A	X Walk 2 Width (in)	N/A
	X Walk 1 Slope (%)	3.8		X Walk 2 Slope (%)	N/A
	X Walk 1 X Slope (%)	2.1		X Walk 2 X Slope (%)	N/A

Remove & Replace Entire Ramp.

Total Cost: \$ 1850.00
