Access Compliance Report

Public Rights-of-Way (Curb Ramps)

Intersection ID: 10009418	Main Street: E_10TH_ST	Cross Street: N_BREVARD_ST	Location: E
ADA ID: 73F0D83A4FA5	Ramp Type: PerpDiag	Initial Pass/Fail: Fail	Overall Compliance: No Severity Score: 13.75

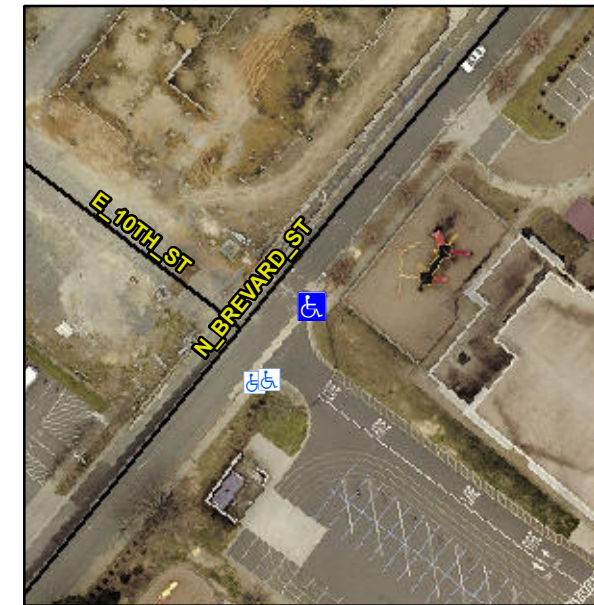
Not Found, R304.2.2, R304.5.3

Compliance	Description	Data	Compliance	Description	Data
N/A	Ramp Length (in)	49.0	No	Ramp Slope (%)	8.6
Yes	Ramp Width (in)	48.0	No	Ramp XSlope (%)	3.3
N/A	Flare Type LT	N/A	N/A	Flare Type RT	N/A
N/A	Flare Slope LT (%)	N/A	N/A	Flare Slope RT (%)	N/A
N/A	Flare Traversable LT?	N/A	N/A	Flare Traversable RT?	N/A
N/A	Landing Length (in)	N/A	N/A	DWS Provided?	N/A
N/A	Landing Width (in)	N/A	N/A	DWS Contrast?	N/A
N/A	Landing Slope (%)	N/A	N/A	DWS Length (in)	N/A
N/A	Landing X Slope (%)	N/A	N/A	DWS Full Width?	N/A
N/A	Landing Curb? (Y/N)	N/A	N/A	DWS Offset (in)	N/A
N/A	Shared Landing?	N/A			
N/A	Gutter Ponding?	N/A	N/A	Gutter Slope (%)	N/A
N/A	Gutter Lip Ht (in)	N/A	N/A	Gutter X Slope (%)	N/A
N/A	Painted X Walk1?	No	N/A	Painted X Walk2?	No
	X Walk 1 Direction	To NW		X Walk 2 Direction	To SW
N/A	X Walk 1 Width (in)	N/A	N/A	X Walk 2 Width (in)	N/A
	X Walk 1 Slope (%)	2.3		X Walk 2 Slope (%)	1.5
	X Walk 1 X Slope (%)	2.7		X Walk 2 X Slope (%)	0.1

N/A	Ramp inside XWalk1?	N/A	N/A	Ramp inside XWalk2?	N/A
	Road Slope (%)	3.0	N/A	Clear Space?	N/A
	Road X Slope (%)	4.0	N/A	Clear Space to XWalk (in)	N/A
N/A	Any Obstructions?	N/A	N/A	Storm Grate/Utility Hazard?	N/A
	Obstruction Type			Storm Grate/Utility Type	
		N/A			N/A
			Yes	Surface Condition? (G/P)	Good

Remove & Replace Curb Ramp With Two New Directional Ramps or Equivalent.
