Intersection ID: 10347	Main Street: KARENDALE_AV	Cross Street: ROGERS_ST	Location:	W
ADA ID: 740681668518	Ramp Type: Perp	Initial Pass/Fail: Fail	Overall Compliance: No	Severity Score: 13.75

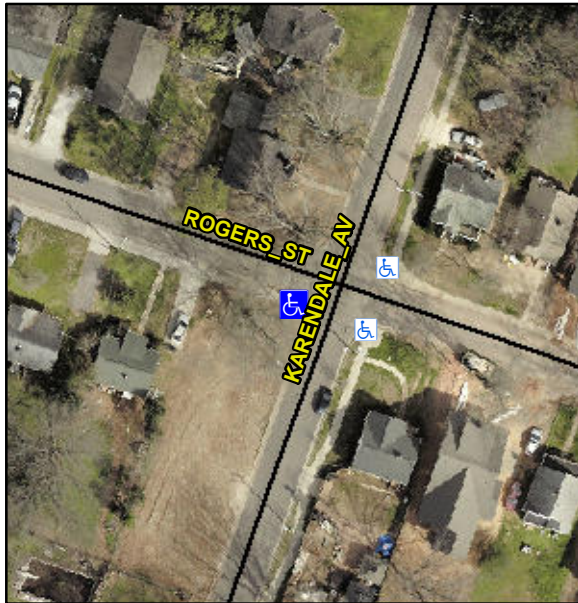
Not Found, R304.2.2

Compliance	Description	Data	Compliance	Description	Data
N/A	Ramp Length (in)	75.0	No	Ramp Slope (%)	8.7
Yes	Ramp Width (in)	50.0	Yes	Ramp XSlope (%)	3.1
N/A	Flare Type LT	N/A	N/A	Flare Type RT	N/A
N/A	Flare Slope LT (%)	N/A	N/A	Flare Slope RT (%)	N/A
N/A	Flare Traversable LT?	N/A	N/A	Flare Traversable RT?	N/A
N/A	Landing Length (in)	N/A	N/A	DWS Provided?	N/A
N/A	Landing Width (in)	N/A	N/A	DWS Contrast?	N/A
N/A	Landing Slope (%)	N/A	N/A	DWS Length (in)	N/A
N/A	Landing X Slope (%)	N/A	N/A	DWS Full Width?	N/A
N/A	Landing Curb? (Y/N)	N/A	N/A	DWS Offset (in)	N/A
N/A	Shared Landing?	N/A			
N/A	Gutter Ponding?	N/A	N/A	Gutter Slope (%)	N/A
N/A	Gutter Lip Ht (in)	N/A	N/A	Gutter X Slope (%)	N/A
N/A	Painted X Walk1?	No	N/A	Painted X Walk2?	N/A
	X Walk 1 Direction	To SE		X Walk 2 Direction	N/A
N/A	X Walk 1 Width (in)	N/A	N/A	X Walk 2 Width (in)	N/A
	X Walk 1 Slope (%)	2.9		X Walk 2 Slope (%)	N/A
	X Walk 1 X Slope (%)	3.1		X Walk 2 X Slope (%)	N/A

N/A	Ramp inside XWalk1?	N/A	N/A	Ramp inside XWalk2?	N/A
	Road Slope (%)	N/A	N/A	Clear Space?	N/A
	Road X Slope (%)	N/A	N/A	Clear Space to XWalk (in)	N/A
N/A	Any Obstructions?	N/A	N/A	Storm Grate/Utility Hazard?	N/A
	Obstruction Type			Storm Grate/Utility Type	
		N/A			N/A
			Yes	Surface Condition? (G/P)	Good

Possible Solutions:

Remove & Replace Entire Ramp.
