Access Compliance Report

Public Rights-of-Way

(Curb Ramps)

Intersection ID: 30473	Main Street: BEDDINGFIELD_DR	Cross Street: PLANTERS_ROW_DR	Location: SW
ADA ID: 7440EB1D02C4	Ramp Type: PerpDiag	Initial Pass/Fail: Fail	Overall Compliance: No
Severity Score: 13.75			
Codes/Mitigation Info/Possible Solution		Field Measurements/Component Compliance

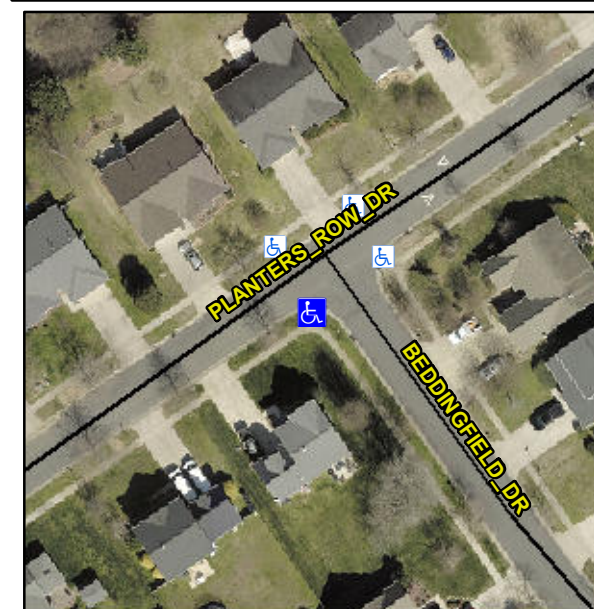
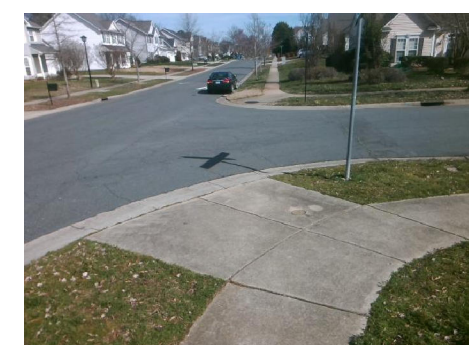
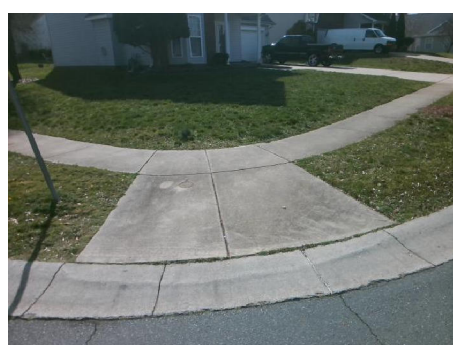
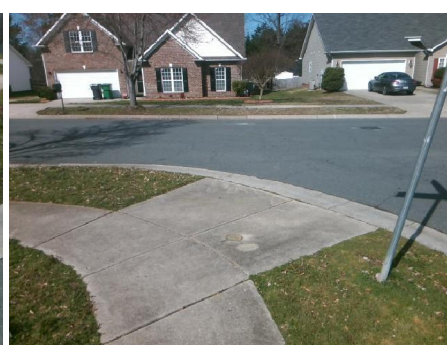
Compliance	Description	Data	Compliance	Description	Data
N/A	Ramp Length (in)	83.0	No	Ramp Slope (%)	8.9
Yes	Ramp Width (in)	48.0	No	Ramp XSlope (%)	2.1
N/A	Flare Type LT	N/A	N/A	Flare Type RT	N/A
N/A	Flare Slope LT (%)	N/A	N/A	Flare Slope RT (%)	N/A
N/A	Flare Traversable LT?	N/A	N/A	Flare Traversable RT?	N/A
N/A	Landing Length (in)	N/A	N/A	DWS Provided?	N/A
N/A	Landing Width (in)	N/A	N/A	DWS Contrast?	N/A
N/A	Landing Slope (%)	N/A	N/A	DWS Length (in)	N/A
N/A	Landing X Slope (%)	N/A	N/A	DWS Full Width?	N/A
N/A	Landing Curb? (Y/N)	N/A	N/A	DWS Offset (in)	N/A
N/A	Shared Landing?	N/A			
N/A	Gutter Ponding?	N/A	N/A	Gutter Slope (%)	N/A
N/A	Gutter Lip Ht (in)	N/A	N/A	Gutter X Slope (%)	N/A
N/A	Painted X Walk1?	No	N/A	Painted X Walk2?	No
	X Walk 1 Direction	To NE		X Walk 2 Direction	To NW
N/A	X Walk 1 Width (in)	N/A	N/A	X Walk 2 Width (in)	N/A
	X Walk 1 Slope (%)	0.4		X Walk 2 Slope (%)	2.5
	X Walk 1 X Slope (%)	0.3		X Walk 2 X Slope (%)	2.2

N/A	Ramp inside XWalk1?	N/A	N/A	Ramp inside XWalk2?	N/A
	Road Slope (%)	1.5	N/A	Clear Space?	N/A
	Road X Slope (%)	0.8	N/A	Clear Space to XWalk (in)	N/A
N/A	Any Obstructions?	N/A	N/A	Storm Grate/Utility Hazard?	N/A
	Obstruction Type			Storm Grate/Utility Type	
		N/A			N/A
			Yes	Surface Condition? (G/P)	Good

Possible Solutions:

Remove & Replace Curb Ramp With Two New Directional Ramps or Equivalent.

R304.2.2, R304.5.3
