Access Compliance Report Public Rights-of-Way (Curb Ramps)

Intersection ID: 20495 Main Street: BRIDLE_STONE_CT Cross Street: STEELECHASE_DR Location: NW

ADA ID: 744625B3C17B Ramp Type: PerpDiag Initial Pass/Fail: Fail Overall Compliance: No Severity Score: 12.5

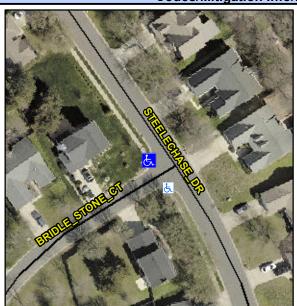
BRIDLE STONE CT StopSign STEELECHASE DR None Possible Solutions:

Comp	liance Descripti	on	Data	Comp	liance	Description	Data
N/A	Ramp Length (in)		99.0	No	Ram	Slope (%)	8.6
Yes	Ramp Width (in)	1	48.0	Yes	Ram	XSlope (%)	1.1
N/A	Flare Type LT		N/A	N/A	Flare	Type RT	N/A
N/A	Flare Slope LT (%)	N/A	N/A	Flare	Slope RT (%)	N/A
N/A	Flare Traversabl	le LT?	N/A	N/A	Flare	Traversable RT?	N/A
N/A	Landing Length	(in)	N/A	N/A	DWS	Provided?	N/A
N/A	Landing Width (i	n)	N/A	N/A	DWS	Contrast?	N/A
N/A	Landing Slope (9	%)	N/A	N/A	DWS	Length (in)	N/A
N/A	Landing X Slope	e (%)	N/A	N/A	DWS	Full Width?	N/A
N/A	Landing Curb? (Y/N)	N/A	N/A	DWS	Offset (in)	N/A
N/A	Shared Landing	?	N/A				
N/A	Gutter Ponding?	>	N/A	N/A	Gutte	er Slope (%)	N/A
N/A	Gutter Lip Ht (in))	N/A	N/A	Gutte	er X Slope (%)	N/A
N/A	Painted X Walk1	!?	No	N/A	Paint	ed X Walk2?	No
	X Walk 1 Direction	on	To SE		X Wa	lk 2 Direction	To NE
N/A	X Walk 1 Width ((in)	N/A	N/A	X Wa	lk 2 Width (in)	N/A
	X Walk 1 Slope ((%)	1.6		X Wa	lk 2 Slope (%)	1.9

X Walk 1 X Slop	e (%)	0.2		X Wa	lk 2 X Slope (%)	3.0
N/A	Ramp inside XW	/alk1?	N/A	N/A	Ram	o inside XWalk2?	N/A
	Road Slope (%)		2.3	N/A	Clear	Space?	N/A
	Road X Slope (%	%)	1.2	N/A	Clear	Space to XWalk (in)	N/A
N/A	Any Obstruction	s?	N/A	N/A	Storn	n Grate/Utility Hazard?	N/A
	Obstruction Type	е			Storn	n Grate/Utility Type	
			N/A				N/A

Remove & Replace Curb Ramp With
Two New Directional Ramps or
Equivalent.

PROW/ADA:
R304.2.2
