Access Compliance Report Public Rights-of-Way (Curb Ramps)

Intersection ID: 13806 Main Street: S_TRYON_ST Cross Street: WEST_BV Location: SE

ADA ID: 7463BEF5A1E2 Ramp Type: Perp Initial Pass/Fail: Fail Overall Compliance: No Severity Score: 13.75

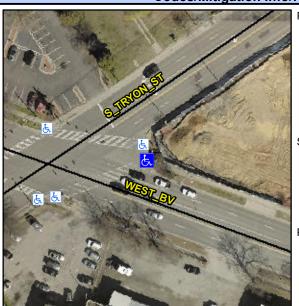
N/A	Ramp Length (in)	54.0	No	Ramp Slope (%)	8.4
Yes	Ramp Width (in)	51.0	No	Ramp XSlope (%)	3.0
N/A	Flare Type LT	N/A	N/A	Flare Type RT	N/A
N/A	Flare Slope LT (%)	N/A	N/A	Flare Slope RT (%)	N/A
N/A	Flare Traversable LT?	N/A	N/A	Flare Traversable RT?	N/A
N/A	Landing Length (in)	N/A	N/A	DWS Provided?	N/A
N/A	Landing Width (in)	N/A	N/A	DWS Contrast?	N/A
N/A	Landing Slope (%)	N/A	N/A	DWS Length (in)	N/A
N/A	Landing X Slope (%)	N/A	N/A	DWS Full Width?	N/A
N/A	Landing Curb? (Y/N)	N/A	N/A	DWS Offset (in)	N/A
N/A	Shared Landing?	N/A			
N/A	Gutter Ponding?	N/A	N/A	Gutter Slope (%)	N/A
N/A	Gutter Lip Ht (in)	N/A	N/A	Gutter X Slope (%)	N/A
N/A	Painted X Walk1?	Yes	N/A	Painted X Walk2?	N/A
	X Walk 1 Direction	To SW		X Walk 2 Direction	N/A
N/A	X Walk 1 Width (in)	114.0	N/A	X Walk 2 Width (in)	N/A
	X Walk 1 Slope (%)	2.2		X Walk 2 Slope (%)	N/A
	X Walk 1 X Slope (%)	1.9		X Walk 2 X Slope (%)	N/A
N/A	Ramp inside XWalk1?	Yes	N/A	Ramp inside XWalk2?	N/A

Road Slope (%)	N/A	N/A	Clear Space?	N/A
	Road X Slope (%)	N/A	N/A	Clear Space to XWalk (in)	N/A
N/A	Any Obstructions?	N/A	N/A	Storm Grate/Utility Hazard?	N/A
	Obstruction Type			Storm Grate/Utility Type	
		N/A			N/A
			Yes	Surface Condition? (G/P)	Good

71 CCCIDIO CCIGNON		i iola ilio	
Possible Solutions:	Comp	liance Description	
Remove & Replace Entire Ramp.	N/A	Ramp Length (in)	
	Yes	Ramp Width (in)	
	N/A	Flare Type LT	
	N/A	Flare Slope LT (%)	
	N/A	Flare Traversable LT	
	N/A	Landing Length (in)	
Surveyor Notes:	N/A	Landing Width (in)	
N/A	N/A	Landing Slope (%)	
	N/A	Landing X Slope (%)	
	N/A	Landing Curb? (Y/N)	
	N/A	Shared Landing?	
PROW/ADA:	N/A	Gutter Ponding?	
R304.2.2, R304.5.3	N/A	Gutter Lip Ht (in)	
	N/A	Painted X Walk1?	
		X Walk 1 Direction	
	N/A	X Walk 1 Width (in)	
		X Walk 1 Slope (%)

Total Cost: \$ 1850.00
