# Access Compliance Report

## Public Rights-of-Way

### (Curb Ramps)

Intersection ID: 43358	Main Street: PROSPERITY COMMONS DR	Cross Street: ROCKY FORD CLUB RD	Location: SE
ADA ID: 7483F9141B39	Ramp Type: PerpDiag	Initial Pass/Fail: Fail	Overall Compliance: No
Severity Score: 10			
Codes/Mitigation Info/Possible Solution		Field Measurements/Component Compliance

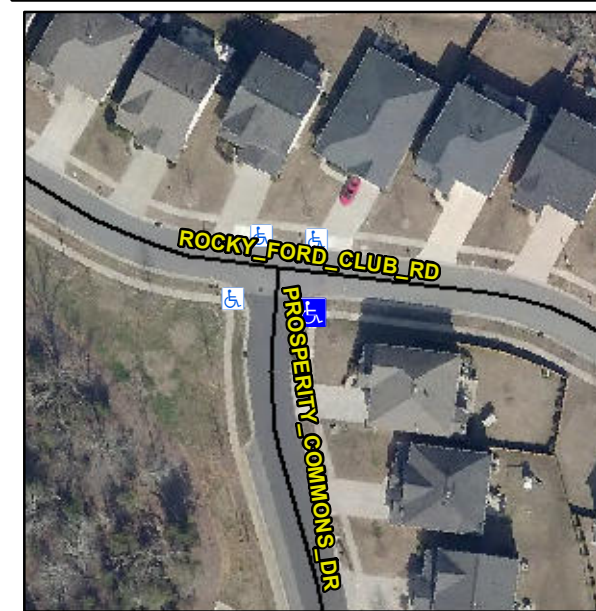
**Not Found, R304.5.1, R304.5.3**

Compliance	Description	Data	Compliance	Description	Data
N/A	Ramp Length (in)	70.0	Yes	Ramp Slope (%)	6.5
No	Ramp Width (in)	46.0	No	Ramp XSlope (%)	2.9
N/A	Flare Type LT	N/A	N/A	Flare Type RT	N/A
N/A	Flare Slope LT (%)	N/A	N/A	Flare Slope RT (%)	N/A
N/A	Flare Traversable LT?	N/A	N/A	Flare Traversable RT?	N/A
N/A	Landing Length (in)	N/A	N/A	DWS Provided?	N/A
N/A	Landing Width (in)	N/A	N/A	DWS Contrast?	N/A
N/A	Landing Slope (%)	N/A	N/A	DWS Length (in)	N/A
N/A	Landing X Slope (%)	N/A	N/A	DWS Full Width?	N/A
N/A	Landing Curb? (Y/N)	N/A	N/A	DWS Offset (in)	N/A
N/A	Shared Landing?	N/A			
N/A	Gutter Ponding?	N/A	N/A	Gutter Slope (%)	N/A
N/A	Gutter Lip Ht (in)	N/A	N/A	Gutter X Slope (%)	N/A
N/A	Painted X Walk1?	No	N/A	Painted X Walk2?	No
	X Walk 1 Direction	To NE		X Walk 2 Direction	To NW
N/A	X Walk 1 Width (in)	N/A	N/A	X Walk 2 Width (in)	N/A
	X Walk 1 Slope (%)	2.1		X Walk 2 Slope (%)	1.5
	X Walk 1 X Slope (%)	1.0		X Walk 2 X Slope (%)	0.3

N/A	Ramp inside XWalk1?	N/A	N/A	Ramp inside XWalk2?	N/A
	Road Slope (%)	1.9	N/A	Clear Space?	N/A
	Road X Slope (%)	2.2	N/A	Clear Space to XWalk (in)	N/A
N/A	Any Obstructions?	N/A	N/A	Storm Grate/Utility Hazard?	N/A
	Obstruction Type			Storm Grate/Utility Type	
		N/A			N/A
			Yes	Surface Condition? (G/P)	Good

**Remove & Replace Curb Ramp With Two New Directional Ramps or Equivalent.**

Total Cost: \$ 3200.00
