Access Compliance Report Public Rights-of-Way (Curb Ramps)

Intersection ID: 50196 Main Street: WEDDINGTON_RD Cross Street: COLONEL_FRANCIS_J_BEATTY_PARK_DR Location: SW

ADA ID: 7492A319D353 Ramp Type: Perp Initial Pass/Fail: Fail Overall Compliance: No Severity Score: 8.75

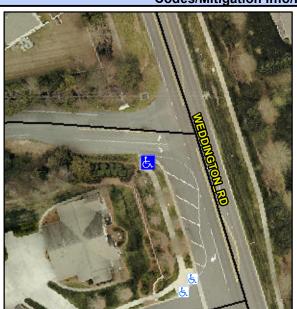
Possible Solution			Fleid Measurements/Component Compilance					
Possible Solutions:			Compliance Description		Data	Compliance Description		Data
Remove & Replace En	tire Ramp.		N/A	Ramp Length (in)	98.0	Yes	Ramp Slope (%)	5.0

•		No	Ramp Width (in)	47.5	Yes	Ramp XSlope (%)	0.9
			N/A	Flare Type LT	N/A	N/A	Flare Type RT	N/A
			N/A	Flare Slope LT (%)	N/A	N/A	Flare Slope RT (%)	N/A
			N/A	Flare Traversable LT?	N/A	N/A	Flare Traversable RT?	N/A
			N/A	Landing Length (in)	N/A	N/A	DWS Provided?	N/A
Surveyor Notes:			N/A	Landing Width (in)	N/A	N/A	DWS Contrast?	N/A
N/A			N/A	Landing Slope (%)	N/A	N/A	DWS Length (in)	N/A
			N/A	Landing X Slope (%)	N/A	N/A	DWS Full Width?	N/A
			N/A	Landing Curb? (Y/N)	N/A	N/A	DWS Offset (in)	N/A
			N/A	Shared Landing?	N/A			
PROW/ADA:			N/A	Gutter Ponding?	N/A	N/A	Gutter Slope (%)	N/A
Not Found, R304.5.1			N/A	Gutter Lip Ht (in)	N/A	N/A	Gutter X Slope (%)	N/A
ŕ			N/A	Painted X Walk1?	No	N/A	Painted X Walk2?	N/A
				X Walk 1 Direction	To N		X Walk 2 Direction	N/A
			N/A	X Walk 1 Width (in)	N/A	N/A	X Walk 2 Width (in)	N/A
				X Walk 1 Slope (%)	1.1		X Walk 2 Slope (%)	N/A
				X Walk 1 X Slope (%)	0.9		X Walk 2 X Slope (%)	N/A

N/A	Ramp inside XWalk1?	N/A	N/A	Ramp inside XWalk2?	N/A	
				Road Slope (%)	N/A	N/A	Clear Space?	N/A
				Road X Slope (%)	N/A	N/A	Clear Space to XWalk (in)	N/A
			N/A	Any Obstructions?	N/A	N/A	Storm Grate/Utility Hazard?	N/A
Total Cost:	\$ 1	850.00		Obstruction Type			Storm Grate/Utility Type	
					N/A			N/A
						Yes	Surface Condition? (G/P)	Good
