Intersection ID: 44215	Main Street: NATIONS_FORD_RD	Cross Street: TYVOLA_GLEN_CR	Location:	S
ADA ID: 74A9E19BD145	Ramp Type: ParaDiag	Initial Pass/Fail: Fail	Overall Compliance: No	Severity Score: 13.75

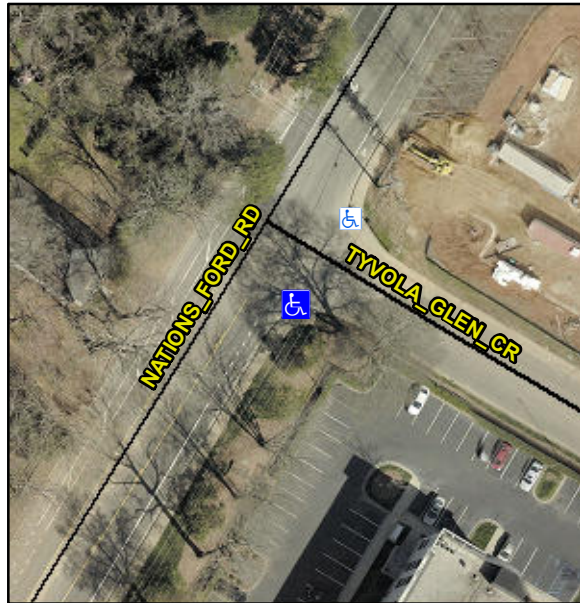
RT RP < 5%

R304.3.2, R304.5.3

Compliance	Description	Data	Compliance	Description	Data
N/A	Ramp Length LT (in)	48.0	N/A	Ramp Length RT (in)	43.0
Yes	Ramp Width LT (in)	84.0	Yes	Ramp Width RT (in)	85.0
No	Ramp Slope LT (%)	9.1	Yes	Ramp Slope RT (%)	1.1
No	Ramp XSlope LT (%)	3.3	No	Ramp XSlope RT (%)	3.5
N/A	Landing Length (in)	N/A	N/A	DWS Provided?	N/A
N/A	Landing Width (in)	N/A	N/A	DWS Contrast?	N/A
N/A	Landing Slope (%)	N/A	N/A	DWS Length (in)	N/A
N/A	Landing X Slope (%)	N/A	N/A	DWS Full Width?	N/A
N/A	Landing Curb? (Y/N)	N/A	N/A	DWS Offset (in)	N/A
N/A	Shared Landing?	N/A			
N/A	Gutter Ponding?	N/A	N/A	Gutter Slope (%)	N/A
N/A	Gutter Lip Ht (in)	N/A	N/A	Gutter X Slope (%)	N/A
N/A	Painted X Walk1?	No	N/A	Painted X Walk2?	No
	X Walk 1 Direction	To NE		X Walk 2 Direction	To NW
N/A	X Walk 1 Width (in)	N/A	N/A	X Walk 2 Width (in)	N/A
	X Walk 1 Slope (%)	1.2		X Walk 2 Slope (%)	0.9
	X Walk 1 X Slope (%)	0.7		X Walk 2 X Slope (%)	1.3
N/A	Ramp inside XWalk1?	N/A	N/A	Ramp inside XWalk2?	N/A

Road Slope (%)	2.6	N/A	Clear Space?	N/A
	Road X Slope (%)	0.2	N/A	Clear Space to XWalk (in)	N/A
N/A	Any Obstructions?	N/A	N/A	Storm Grate/Utility Hazard?	N/A
	Obstruction Type			Storm Grate/Utility Type	
		N/A			N/A
			Yes	Surface Condition? (G/P)	Good
			N/A	Curb Slope (%)	14.6

Remove & Replace Curb Ramp With Two New Directional Ramps or Equivalent.
