Access Compliance Report Public Rights-of-Way (Curb Ramps)

Intersection ID: 5117 Main Street: SPECTOR DR **Cross Street: STATESVILLE RD** Location: NE **Overall Compliance: No Severity Score:** ADA ID: 74B524C80B6C Ramp Type: BlendTrans1 Initial Pass/Fail: Pass 22.5

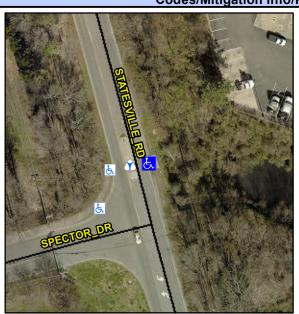
STATESVILLE RD Street 1 Name Stop Condition-Street 1 None N/A Street 2 Name Stop Condition-Street 2 N/A Possible Solutions: Remove & Replace Detectable Warning System. Relocate Obstruction. Surveyor Notes: NO CURB, NO SW, DWS OS **MEASRUED TO ASP** PROW/ADA: R305.1.4, R305.2, R302.3, R402.2

OTHER: TRANSIT SIGN LEANING OVER LNDG
