## **Access Compliance Report Public Rights-of-Way** (Curb Ramps)

Intersection ID: 48768 Main Street: SONOMA\_VALLEY\_DR **Cross Street: MINITREE LN** Location: SE **ADA ID: 74BA414EDB0F** Ramp Type: BlendTrans1 Initial Pass/Fail: Fail **Overall Compliance: No Severity Score:** 10

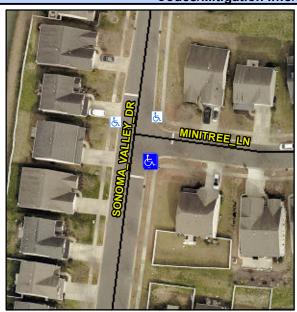
Compliance Description		Data	Compliance Description		Data
N/A	Ramp Length (in)	72.5	Yes	BlendTrans Slope (%)	4.3
No	Ramp Width (in)	47.0	No	BlendTrans XSlope (%)	4.7
N/A	Flare Type LT	N/A	N/A	Flare Type RT	N/A
N/A	Flare Slope LT (%)	N/A	N/A	Flare Slope RT (%)	N/A
N/A	Flare Traversable LT?	N/A	N/A	Flare Traversable RT?	N/A
N/A	Landing Length (in)	N/A	N/A	DWS Provided?	N/A
N/A	Landing Width (in)	N/A	N/A	DWS Contrast?	N/A
N/A	Landing Slope (%)	N/A	N/A	DWS Length (in)	N/A
N/A	Landing X Slope (%)	N/A	N/A	DWS Full Width?	N/A
N/A	Landing Curb? (Y/N)	N/A	N/A	DWS Offset (in)	N/A
N/A	Shared Landing?	N/A			
N/A	Gutter Ponding?	N/A	N/A	Gutter Slope (%)	N/A
N/A	Gutter Lip Ht (in)	N/A	N/A	Gutter X Slope (%)	N/A
N/A	Painted X Walk1?	No	N/A	Painted X Walk2?	No
	X Walk 1 Direction	To N		X Walk 2 Direction	To W
	X Walk 1 Width (in)	N/A		X Walk 2 Width (in)	N/A
	X Walk 1 Slope (%)	2.8		X Walk 2 Slope (%)	2.5
	X Walk 1 X Slope (%)	1.8		X Walk 2 X Slope (%)	0.1

N/A	Ramp inside XWalk1?	N/A	N/A	Ramp inside XWalk2?	N/A
	Road Slope (%)	1.1		Clear Space?	N/A
	Road X Slope (%)	0.2	N/A	Clear Space to XWalk (in)	N/A
N/A	Any Obstructions?	N/A	N/A	Storm Grate/Utility Hazard?	N/A
	Obstruction Type			Storm Grate/Utility Type	
		N/A			N/A
			Yes	Surface Condition? (G/P)	Good

No

Curb Slope (%)

20.3

Possible Solutions: Remove & Replace Curb Ramp With Two New Directional Ramps or Equivalent. Surveyor Notes: N/A PROW/ADA: Not Found, R304.5.1, R304.5.3
