Access Compliance Report

Public Rights-of-Way

(Curb Ramps)

Intersection ID: N/A	Main Street: E_STONEWALL_ST	Cross Street: S_CALDWELL_ST	Location: N
ADA ID: 74C637AAD3D0	Ramp Type: BlendTrans1	Initial Pass/Fail: Pass	Overall Compliance: No
		Severity Score: 0

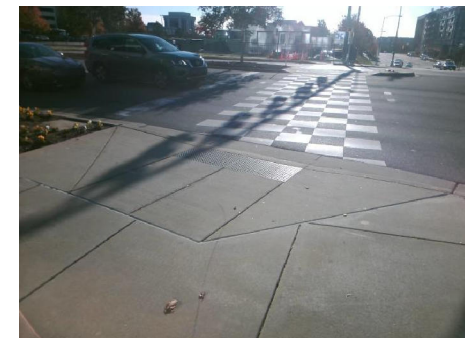
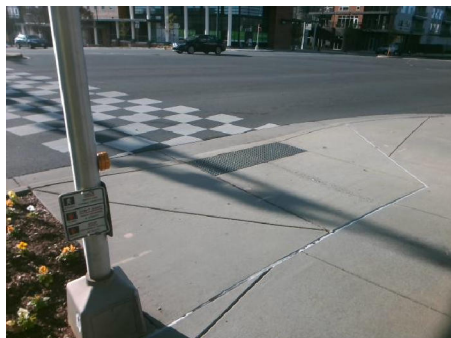
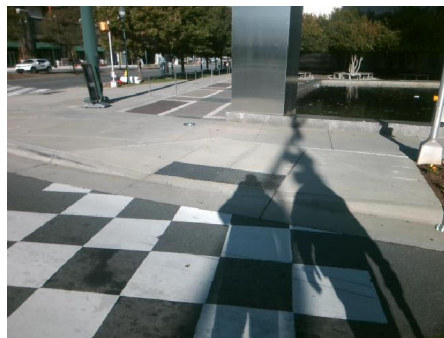
Compliance	Description	Data	Compliance	Description	Data
N/A	Ramp Length (in)	92.0	Yes	BlendTrans Slope (%)	1.1
Yes	Ramp Width (in)	72.0	Yes	BlendTrans XSlope (%)	0.7
N/A	Flare Type LT	Sloped	N/A	Flare Type RT	Sloped
N/A	Flare Slope LT (%)	6.9	N/A	Flare Slope RT (%)	4.6
N/A	Flare Traversable LT?	No	N/A	Flare Traversable RT?	No
Yes	Landing Length (in)	73.0	Yes	DWS Provided?	Yes
Yes	Landing Width (in)	72.0	Yes	DWS Contrast?	Yes
Yes	Landing Slope (%)	0.6	Yes	DWS Length (in)	24.5
Yes	Landing X Slope (%)	0.3	Yes	DWS Full Width?	Yes
N/A	Landing Curb? (Y/N)	No	Yes	DWS Offset (in)	0.5
N/A	Shared Landing?	No			
Yes	Gutter Ponding?	No	Yes	Gutter Slope (%)	0.0
Yes	Gutter Lip Ht (in)	0.0	Yes	Gutter X Slope (%)	1.1
N/A	Painted X Walk1?	Yes	N/A	Painted X Walk2?	N/A
	X Walk 1 Direction	To SE		X Walk 2 Direction	N/A
	X Walk 1 Width (in)	144.0		X Walk 2 Width (in)	N/A
	X Walk 1 Slope (%)	1.6		X Walk 2 Slope (%)	N/A
	X Walk 1 X Slope (%)	0.2		X Walk 2 X Slope (%)	N/A

Yes	Ramp inside XWalk1?	Yes	N/A	Ramp inside XWalk2?	N/A
	Road Slope (%)	0.2		Clear Space?	Yes
	Road X Slope (%)	1.6	N/A	Clear Space to XWalk (in)	N/A
Yes	Any Obstructions?	No	Yes	Storm Grate/Utility Hazard?	No
	Obstruction Type			Storm Grate/Utility Type	
		N/A			N/A
			Yes	Surface Condition? (G/P)	Good
			No	Curb Slope (%)	7.1

Remove & Replace Curb Slope and Extend Ramp.
