Access Compliance Report

Public Rights-of-Way

(Curb Ramps)

| Intersection ID: 49551 | Main Street: STEEL_GARDENS_BV | Cross Street: NODA_BV | Location: SE |

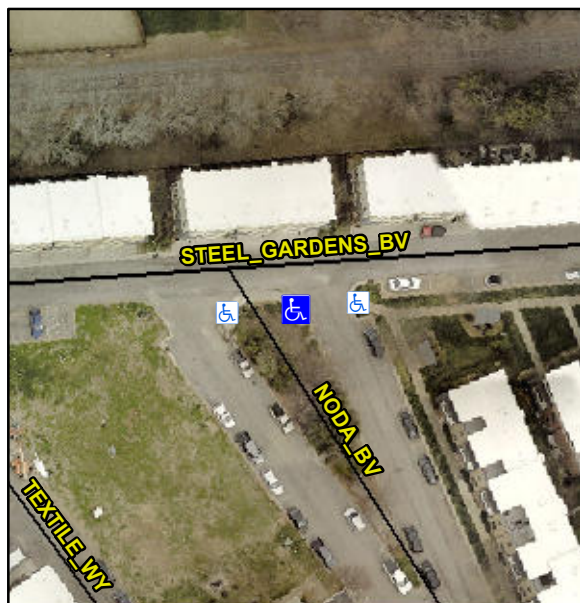
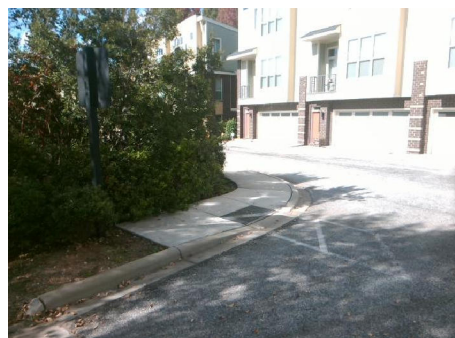
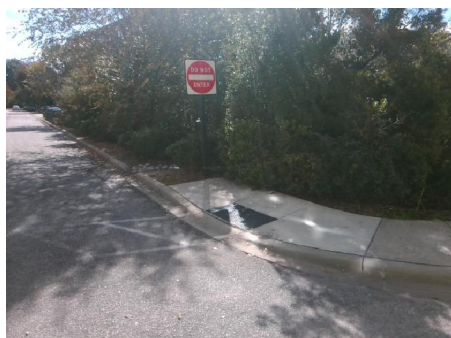
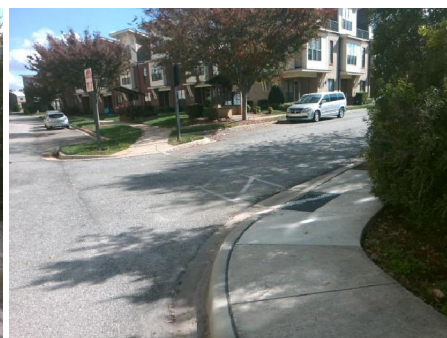
| ADA ID: 74C7BB865ABD | Ramp Type: Perp | Initial Pass/Fail: Fail | Overall Compliance: No |

| Codes/Mitigation Info/Possible Solution | | | Severity Score: 25 |

Not Found, R304.2.2

| Compliance | Description | Data | Compliance | Description | Data |
|---|---|---|---|---|---|
| N/A | Ramp Length (in) | 61.0 | No | Ramp Slope (%) | 13.4 |
| Yes | Ramp Width (in) | 48.0 | Yes | Ramp XSlope (%) | 1.0 |
| | | | Yes | Surface Condition? (G/P) | Good |

Remove & Replace Entire Ramp.
