# Access Compliance Report

## Public Rights-of-Way

### (Curb Ramps)

| Intersection ID: 53405 | Main Street: LUTHER_ST | Cross Street: MORGAN_PARK_DR | Location: W |

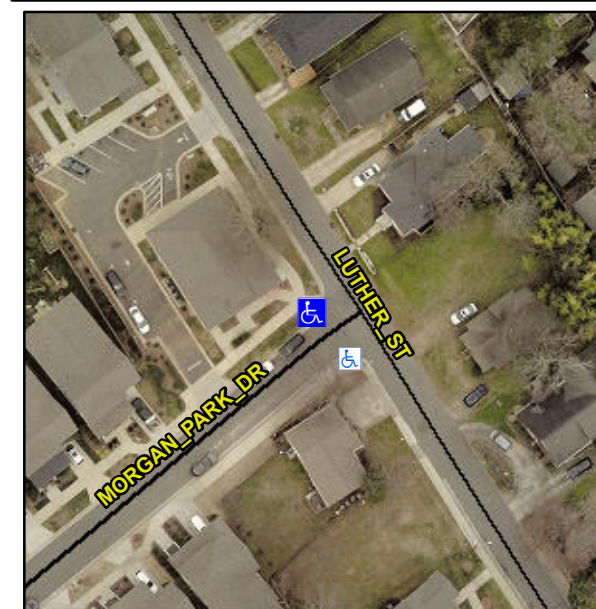
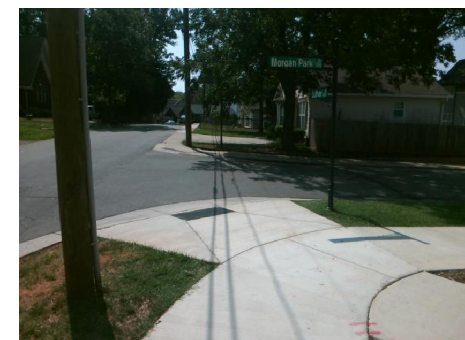
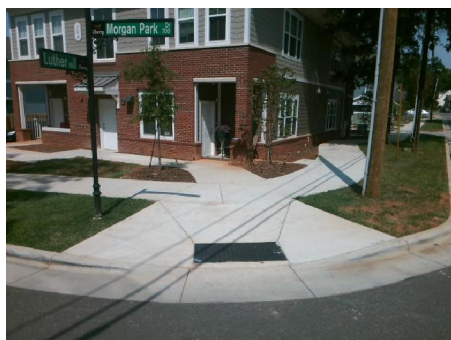
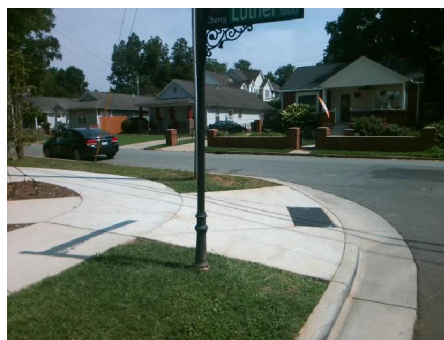
| ADA ID: 74CC1EEBF968 | Ramp Type: BlendTrans1 | Initial Pass/Fail: Pass | Overall Compliance: No |

**R305.2**

| Compliance | Description | Data | Compliance | Description | Data |
|---|---|---|---|---|---|
| N/A | Landing Curb? (Y/N) | No | No | DWS Offset (in) | 5.0 |

**Remove & Replace Detectable Warning System.**

**\$ 800.00**
