# Access Compliance Report

## Public Rights-of-Way

### (Curb Ramps)

Intersection ID: 10012666	Main Street: RUTHERGLEN_CT	Cross Street: N/A	Location: NW
ADA ID: 74CFA873ADE8	Ramp Type: Perp	Initial Pass/Fail: Fail	Overall Compliance: No
Severity Score: 35			
Codes/Mitigation Info/Possible Solution		Field Measurements/Component Compliance

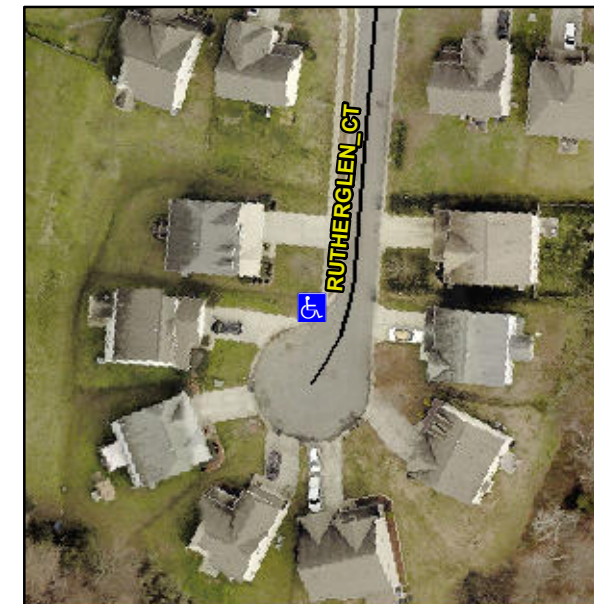
**Not Found, R304.5.1, R304.2.2, R304.5.3**

Compliance	Description	Data	Compliance	Description	Data
N/A	Ramp Length (in)	48.0	No	Ramp Slope (%)	12.8
No	Ramp Width (in)	44.5	No	Ramp XSlope (%)	3.5
N/A	Flare Type LT	N/A	N/A	Flare Type RT	N/A
N/A	Flare Slope LT (%)	N/A	N/A	Flare Slope RT (%)	N/A
N/A	Flare Traversable LT?	N/A	N/A	Flare Traversable RT?	N/A
N/A	Landing Length (in)	N/A	N/A	DWS Provided?	N/A
N/A	Landing Width (in)	N/A	N/A	DWS Contrast?	N/A
N/A	Landing Slope (%)	N/A	N/A	DWS Length (in)	N/A
N/A	Landing X Slope (%)	N/A	N/A	DWS Full Width?	N/A
N/A	Landing Curb? (Y/N)	N/A	N/A	DWS Offset (in)	N/A
N/A	Shared Landing?	N/A			
N/A	Gutter Ponding?	N/A	N/A	Gutter Slope (%)	N/A
N/A	Gutter Lip Ht (in)	N/A	N/A	Gutter X Slope (%)	N/A
N/A	Painted X Walk1?	No	N/A	Painted X Walk2?	N/A
	X Walk 1 Direction	To SE		X Walk 2 Direction	N/A
N/A	X Walk 1 Width (in)	N/A	N/A	X Walk 2 Width (in)	N/A
	X Walk 1 Slope (%)	0.2		X Walk 2 Slope (%)	N/A
	X Walk 1 X Slope (%)	1.7		X Walk 2 X Slope (%)	N/A

N/A	Ramp inside XWalk1?	N/A	N/A	Ramp inside XWalk2?	N/A
	Road Slope (%)	N/A	N/A	Clear Space?	N/A
	Road X Slope (%)	N/A	N/A	Clear Space to XWalk (in)	N/A
N/A	Any Obstructions?	N/A	N/A	Storm Grate/Utility Hazard?	N/A
	Obstruction Type			Storm Grate/Utility Type	
		N/A			N/A
			Yes	Surface Condition? (G/P)	Good

**Remove & Replace Entire Ramp.**

Total Cost: \$ 1850.00
