Access Compliance Report

Public Rights-of-Way

(Curb Ramps)

Intersection ID: 18144	Main Street: BRANDYWINE_RD	Cross Street: WESTFIELD_RD	Location: NW
ADA ID: 74D22FA78EDB	Ramp Type: PerpDiag	Initial Pass/Fail: Fail	Overall Compliance: No
		Severity Score: 10

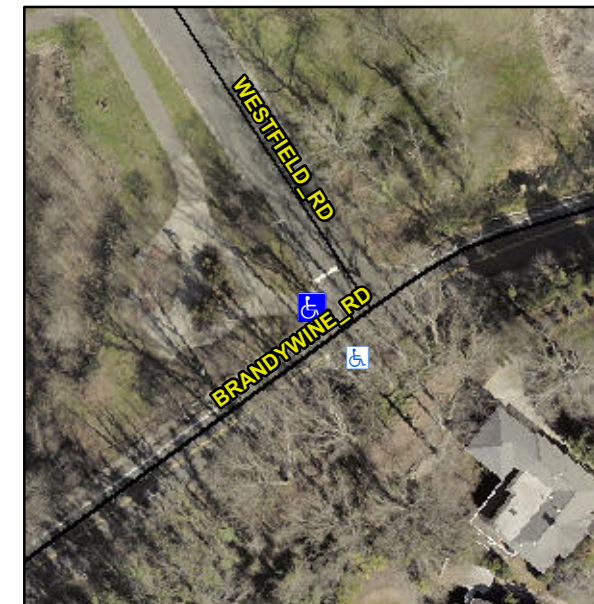
Not Found, R304.5.1, R304.5.3

Compliance	Description	Data	Compliance	Description	Data
N/A	Ramp Length (in)	43.0	Yes	Ramp Slope (%)	8.0
No	Ramp Width (in)	47.0	No	Ramp XSlope (%)	2.2
N/A	Flare Type LT	N/A	N/A	Flare Type RT	N/A
N/A	Flare Slope LT (%)	N/A	N/A	Flare Slope RT (%)	N/A
N/A	Flare Traversable LT?	N/A	N/A	Flare Traversable RT?	N/A
N/A	Landing Length (in)	N/A	N/A	DWS Provided?	N/A
N/A	Landing Width (in)	N/A	N/A	DWS Contrast?	N/A
N/A	Landing Slope (%)	N/A	N/A	DWS Length (in)	N/A
N/A	Landing X Slope (%)	N/A	N/A	DWS Full Width?	N/A
N/A	Landing Curb? (Y/N)	N/A	N/A	DWS Offset (in)	N/A
N/A	Shared Landing?	N/A			
N/A	Gutter Ponding?	N/A	N/A	Gutter Slope (%)	N/A
N/A	Gutter Lip Ht (in)	N/A	N/A	Gutter X Slope (%)	N/A
N/A	Painted X Walk1?	No	N/A	Painted X Walk2?	No
	X Walk 1 Direction	To SE		X Walk 2 Direction	To NE
N/A	X Walk 1 Width (in)	N/A	N/A	X Walk 2 Width (in)	N/A
	X Walk 1 Slope (%)	5.2		X Walk 2 Slope (%)	7.0
	X Walk 1 X Slope (%)	5.6		X Walk 2 X Slope (%)	5.2

N/A	Ramp inside XWalk1?	N/A	N/A	Ramp inside XWalk2?	N/A
	Road Slope (%)	1.1	N/A	Clear Space?	N/A
	Road X Slope (%)	8.2	N/A	Clear Space to XWalk (in)	N/A
N/A	Any Obstructions?	N/A	N/A	Storm Grate/Utility Hazard?	N/A
	Obstruction Type			Storm Grate/Utility Type	
		N/A			N/A
			Yes	Surface Condition? (G/P)	Good

Remove & Replace Curb Ramp With Two New Directional Ramps or Equivalent.
