# Access Compliance Report

## Public Rights-of-Way

### (Curb Ramps)

Intersection ID: 3033	Main Street: DEARMON_RD	Cross Street: BENFIELD_RD	Location:	S
ADA ID: 74D7FE014623	Ramp Type: Perp	Initial Pass/Fail: Fail	Overall Compliance: No	Severity Score: 25
Codes/Mitigation Info/Possible Solution		Field Measurements/Component Compliance

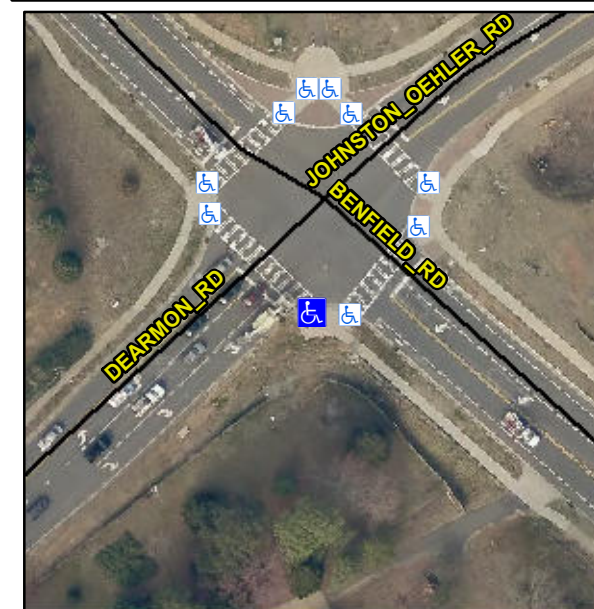
Compliance	Description	Data	Compliance	Description	Data
N/A	Ramp Length (in)	94.0	No	Ramp Slope (%)	12.3
Yes	Ramp Width (in)	74.0	Yes	Ramp XSlope (%)	0.2
N/A	Flare Type LT	N/A	N/A	Flare Type RT	N/A
N/A	Flare Slope LT (%)	N/A	N/A	Flare Slope RT (%)	N/A
N/A	Flare Traversable LT?	N/A	N/A	Flare Traversable RT?	N/A
N/A	Landing Length (in)	N/A	N/A	DWS Provided?	N/A
N/A	Landing Width (in)	N/A	N/A	DWS Contrast?	N/A
N/A	Landing Slope (%)	N/A	N/A	DWS Length (in)	N/A
N/A	Landing X Slope (%)	N/A	N/A	DWS Full Width?	N/A
N/A	Landing Curb? (Y/N)	N/A	N/A	DWS Offset (in)	N/A
N/A	Shared Landing?	N/A			
N/A	Gutter Ponding?	N/A	N/A	Gutter Slope (%)	N/A
N/A	Gutter Lip Ht (in)	N/A	N/A	Gutter X Slope (%)	N/A
N/A	Painted X Walk1?	Yes	N/A	Painted X Walk2?	N/A
	X Walk 1 Direction	To NW		X Walk 2 Direction	N/A
N/A	X Walk 1 Width (in)	120.0	N/A	X Walk 2 Width (in)	N/A
	X Walk 1 Slope (%)	3.0		X Walk 2 Slope (%)	N/A
	X Walk 1 X Slope (%)	2.6		X Walk 2 X Slope (%)	N/A

N/A	Ramp inside XWalk1?	Yes	N/A	Ramp inside XWalk2?	N/A
	Road Slope (%)	N/A	N/A	Clear Space?	N/A
	Road X Slope (%)	N/A	N/A	Clear Space to XWalk (in)	N/A
N/A	Any Obstructions?	N/A	N/A	Storm Grate/Utility Hazard?	N/A
	Obstruction Type			Storm Grate/Utility Type	
		N/A			N/A
			Yes	Surface Condition? (G/P)	Good

Possible Solutions:

**Remove & Replace Entire Ramp.**

**R304.2.2**

**\$ 1850.00**
